Project Review:

SC2000-05

Church in Minneapolis: church building

Inspection Date: October 14, 2004

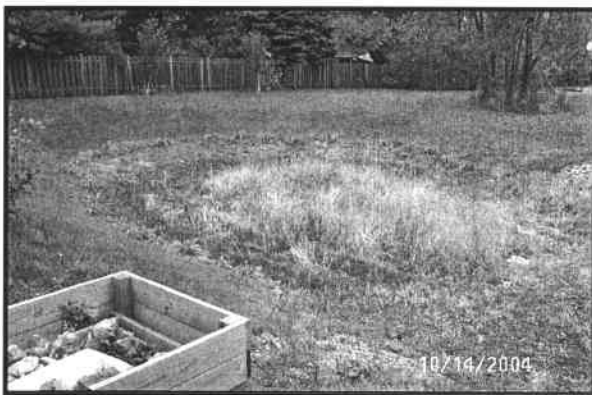
Looking southwest

Pond SW corner outlets overland across adjacent property. Verify flowpath to SS

Inlet (s): Upper riprap area is blocking runoff from parking lot to pond. Minor erosion on upper end of lower riprap area.

Outlet(s): Baffled weir, no obstruction.

Basin(s): Should be permanent pool, but the pond is completely dry.

Comments: Drainage to south is acceptable. No recommended improvements.
