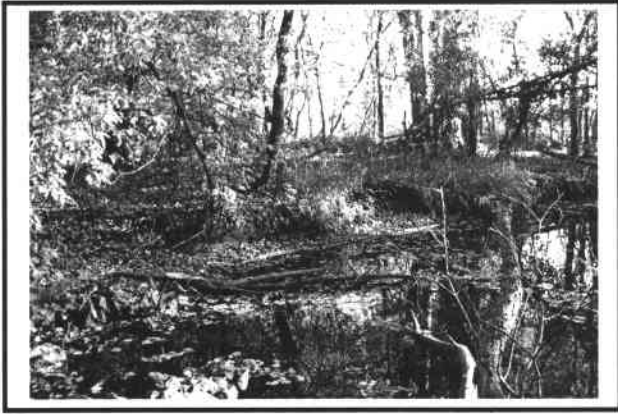
Outlet channel showing downcutting and erosion, woody debris
