**Project Review:****SC2001-15**

Water Tower Place: construction of office building

SE quad I 94 and Fish Lake Road  
1 pond

**Inspection Date:** October 6, 2004

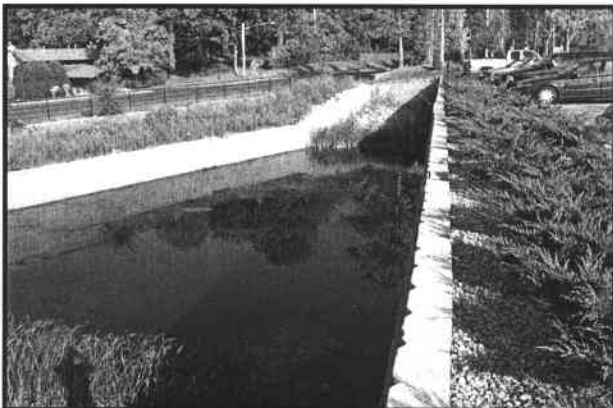
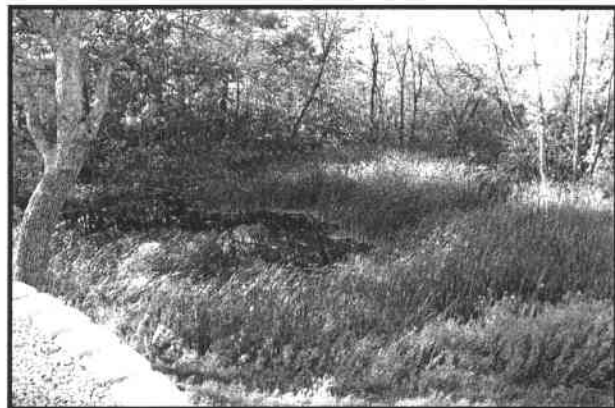
**Inlet (s):** The inlet to the pond is not stabilized with riprap. It appears that the riprap has washed away during storm events. Maintenance is required to replace the riprap around the inlet pipe. Maintenance is required to replace some of the modular blocks that make up the retaining wall that bounds three sides of this pond. Some have fallen off into the pond and can be seen through the pond surface water.

**Outlet(s):** The outlet is a wooden weir. It appears to be functioning properly at this time.

**Basin(s):** A permanent pool is provided. The estimated average depth of the pond is 4 to 5 feet. The side slope, where there are side slopes (three of the side slopes are bound by modular block retaining wall) appears to be well vegetated. Skimming is provided via the weir.

**Comments:** Replace the riprap around the inlet pipe and retaining wall modular blocks that have fallen into the pond.
