**Project Review:****SC2002-07**

The Fields of Nanterre, 164-unit Townhouse Development

**Inspection Date:** October 12, 2004**Comments:** Only one of the two permitted ponds has been installed as of the date of this report.

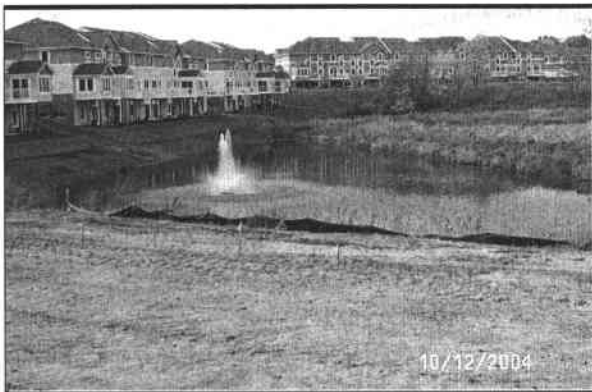
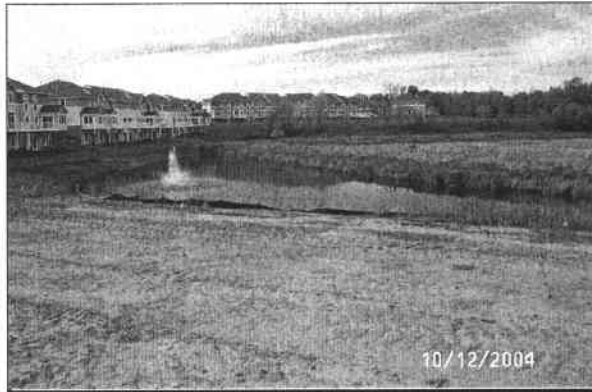
The ponds are on the north edge of the site. The inlets are submerged and stabilized with riprap. The eastern inlet has discharged sediment into the pond. Maintenance should include removing the sediment that has discharged from the inlet into the pond. The western inlet does not have riprap around it. Maintenance should include adding the riprap around the inlet for stabilization.

It appears that the pond outfalls to the wetland to the north via a constructed berm. The maintenance that needs to be taken care of on the berm is to stabilize the overflow spillway.

There is a permanent pool 2 to 3 foot deep. Side slopes are vegetated except for the southern side slope in front of the 4 foot retaining wall adjacent to some of the townhomes. Maintenance should include vegetate the side slopes of the basin. On the southeastern edge of the pond where they have silt fence, it looks like about 18 to 24 inches of sediment has built up in front of the silt fence. That needs to be cleaned up and the silt fence needs to be reinstalled.

Remove sediment from the pond and install riprap at all inlets. Stabilize outlet spillway. Vegetate side slopes. Remove sediment build-up behind silt fence and reinstall silt fence.
