Project Review:**SC2002-10**

The Shoppes @ Arbor Lakes, Commercial Development

Inspection Date: October 21, 2004

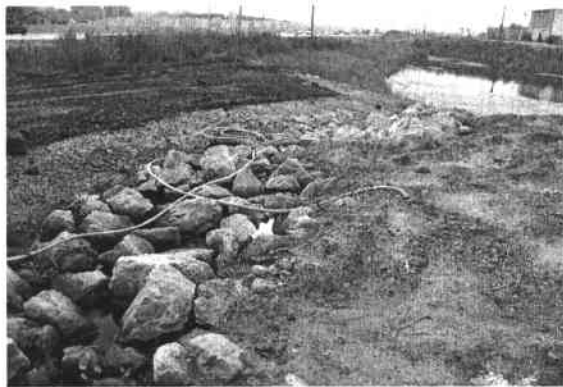
Inlet (s): There are two inlets. The north inlet is well stabilized and does not require maintenance. The east inlet discharges into a rip rapped channel. Vegetation has not been established, and there is some erosion and sediment accumulation.

Channel from east inlet to pond

Comments: Provide temporary erosion control of east side of pond and of the east inlet channel until vegetation is established. Remove accumulated debris.

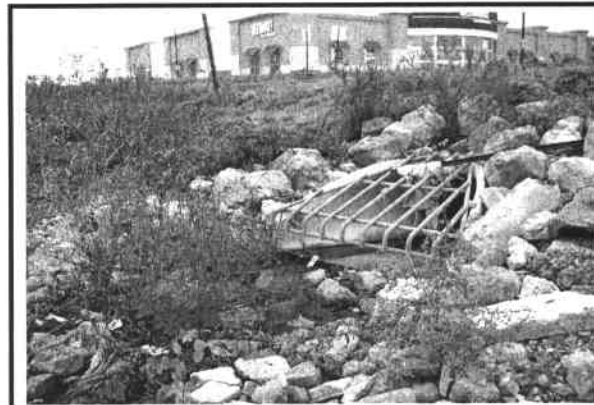
North inlet

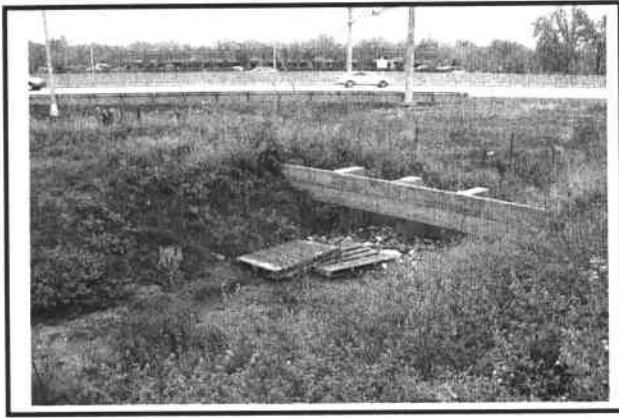
Outlet(s): The outlet is a baffled weir discharging to a highway ditch/pond system. Some debris has accumulated and should be removed.

Outlet with debris

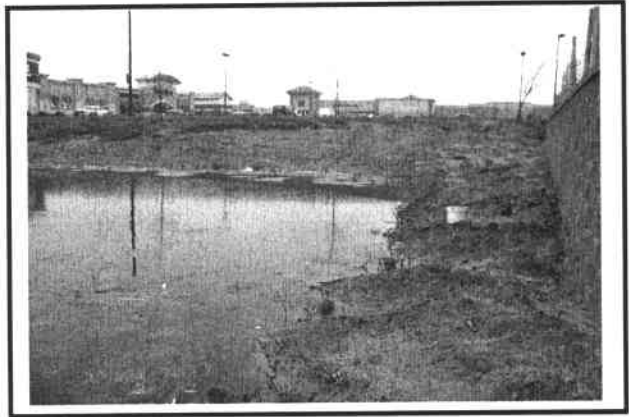
Basin(s): Permanent pool is 3-4 feet deep. Due to construction of a new building the east side of the pond is not vegetated and is eroding into the pond; there is no temporary erosion control provided. Erosion control should be added until side slope vegetation is established.

Unvegetated east side of pond
