**Project Review:**

**SC2003-01**

Way Addition: office condos and office building

Maple Grove

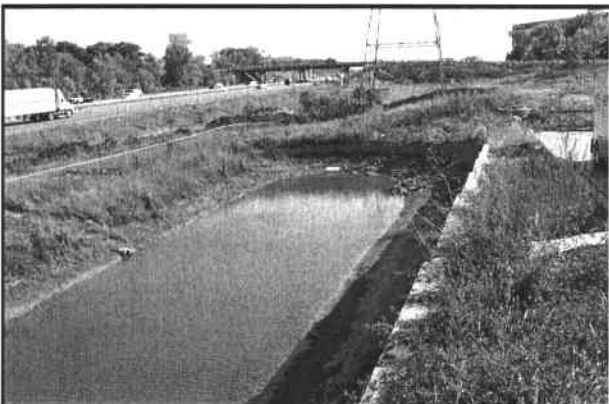
**Inlet (s):** The basin has two inlets. Both inlets have sediment and trash in them. The riprap pads also have sediment and trash in them. Maintenance is required on the inlets and the riprap pads to remove sediments and trash.

**Basin(s):** A permanent pool is provided. Estimated depth to be a couple of feet. The side slopes are vegetated except for at the waterline. There is trash all around the water line. There is a lack of vegetation at the water line.

**Comments:** Remove sediment and trash from the pond. Reseed pond side slopes if vegetation is still lacking.
