Project Review:**WM2003-06**

Orchard Trail: 43 residential lots

Brooklyn Park

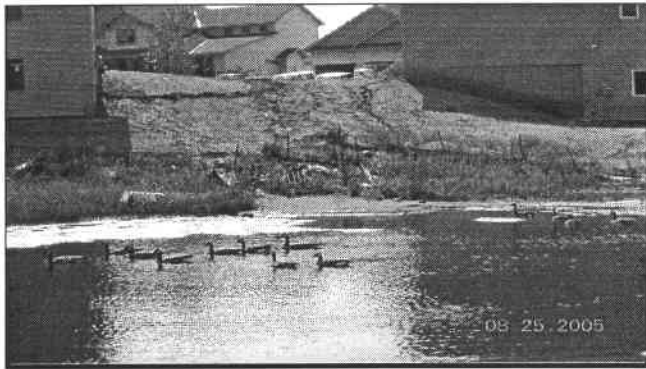
Pond 1 - erosion at southwest inlet

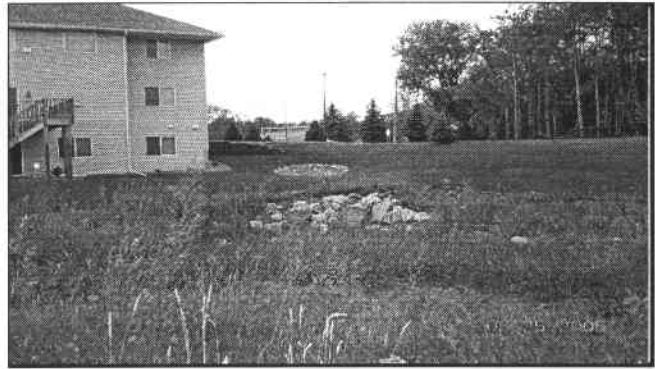
Pond 4 - looking northwest - outlet grate looks high

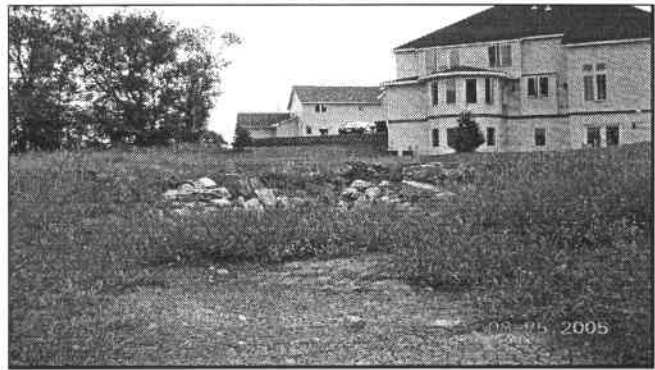
Pond 4 - inlet pipe buried?
