Project Review:

WM2003-07

Shadowbrook: 92 single family units

Inspection Date: August 25, 2005

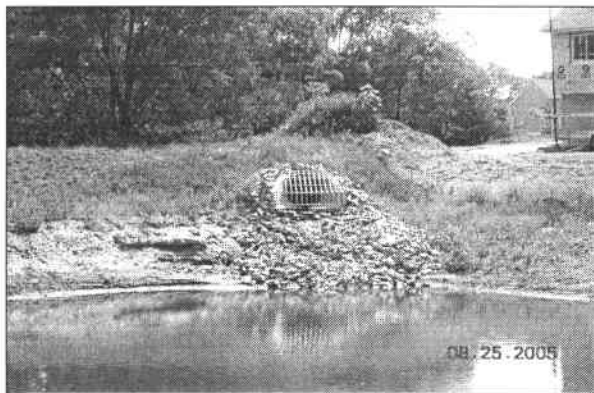
Inlet (s): Severe erosion at southeast inlet of main pond.

Erosion at southeast inlet

Repair erosion at southeast inlet and around pond. Reseed side slopes of pond.

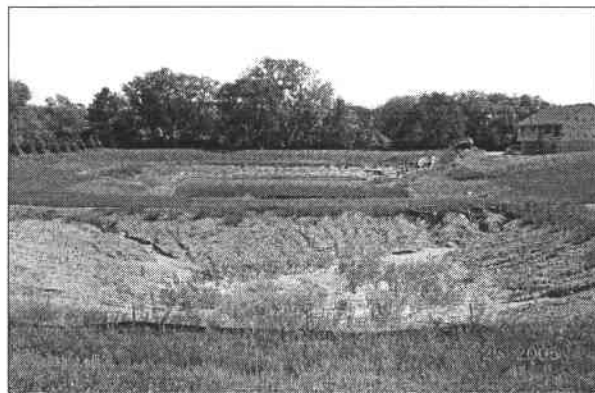
Comments: Small pond at intersection - what is purpose of pond? There is an inlet pipe at northwest corner, but pond is not connected to main pond.

Main pond-background; small pond-foreground
