Project Review:

SC2000-07

SAFECO Products: expansion of existing bldg & parking

9300 W Research Center Rd

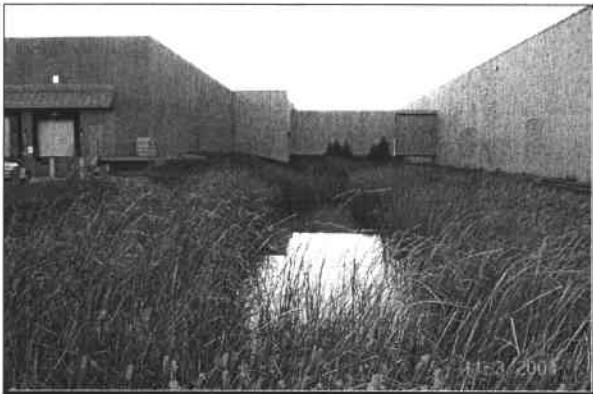
Basin

Basin(s): Depth 4-5'

Comments: Drintile end located and appears to be functioning. Remove sediment from V2B1. Stabilize slopes downstream from roof drains.

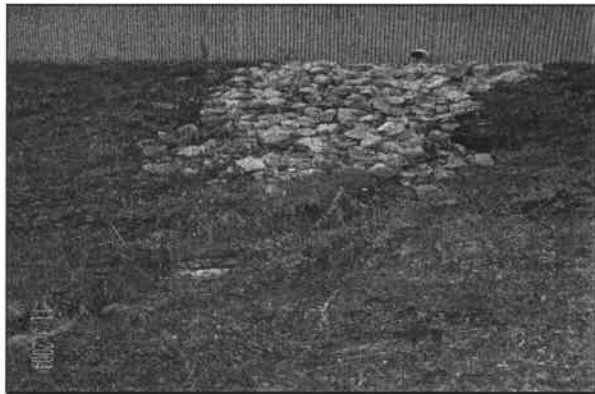
Slopes downstream from roofdrains

Inlet (s): Erosion at side of riprap from roof drains. Stabilize slopes downstream from roof drains.
