Project Review: SC2000-21
Ernst Movers: commercial development

Project Location: MAP: 20
Brooklyn Park
NE quad 85th & Jefferson Highway
1 pond N side

Inspection Date: August 24, 2005

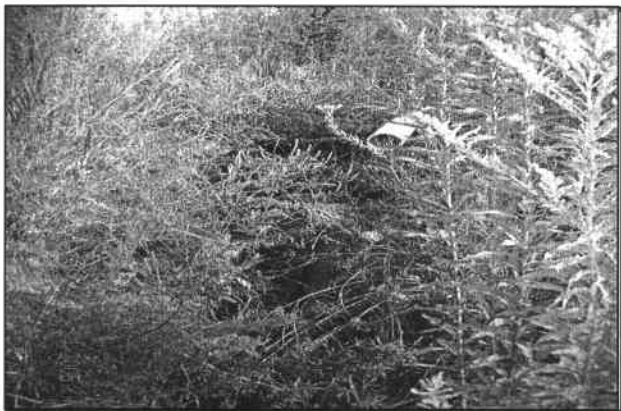
Inlet (s): Southwest corner the riprap is eroded. There is also trash in southwest corner. Significant erosion on north side. PVC drain now connects for a paralell roof drain.

Basin(s): Depth 2-3'. Erosion by roofdrains. Maintenance required.

Northside erosion

Comments: Stabilize multiple areas of erosion on north side of pond.

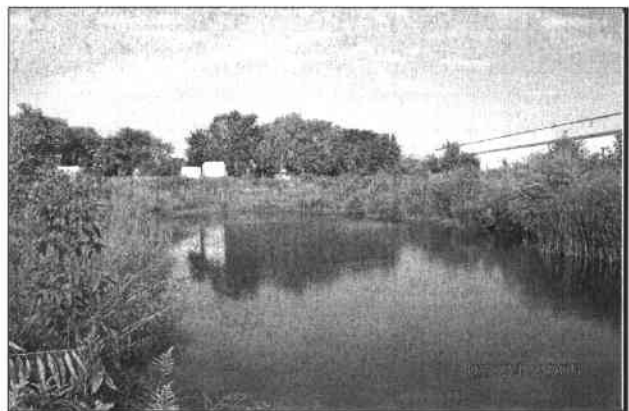
Southeast inlet looking west
