Project Review:

SC2001-12

JPI Development; 300 unit apartments

Project Location:
Plymouth

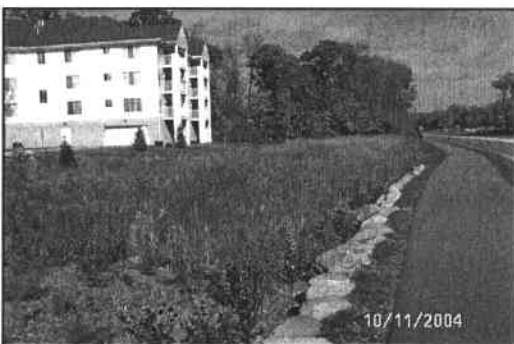
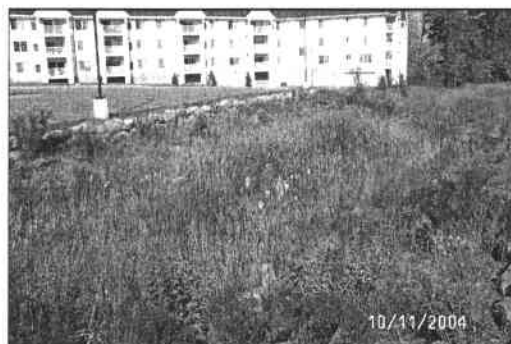
The inlets need to be cleaned out. They have accumulated sediment in them. They are stabilized with riprap.

The inlet is clear of debris. It could use more riprap. There are grasses growing through the riprap. The inlet is in good shape.

The outlet appears to be a 60-inch concrete manhole with an open top and a grate on it, which is acceptable. Skimming is provided. It has an emergency overflow.

The outlet structure has debris blocking the low side. There is no skimming provided. There is no emergency overflow provided.

The basin has a permanent pool. The depth is approximately 2 feet. Side slopes are vegetated slightly. Mostly vegetated (30%-40%); the rest is bark. Maintenance is required on the inlet. Clear the debris out of the flared end sections.

Maintenance required would be to clean this overflow structure and get the weeds and reeds out of there. The permanent pool is provided. The depth by quantity of the reeds is only 1 to 2 feet.

South Basin
Remove sediment from inlets.

North Basin
Remove debris from outlet.
