**Project Review:** SC2002-11  
Hickok North Lot/ Office Showroom

**Project Location:** MAP: 8  
Maple Grove  
NW quadrant 63rd Ave and Sycamore Ln N  
Site discharges to city pond NW of site

**Inspection Date:** October 7, 2004

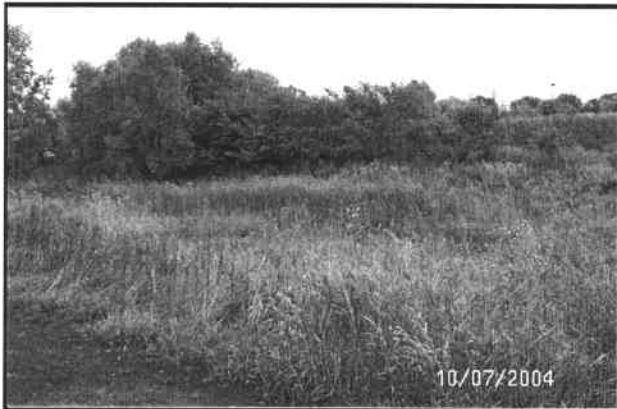
**Inlet (s):** The inlets were not located. Unable to confirm if they are stabilized with riprap or that they are clear of debris. Clear vegetation from around the inlets.

**Outlet(s):** The outlet was not located. It is overgrown with vegetation. Remove debris from around the outlet of the pond. The pond flows northwest to a regional pond. There is no evidence of localized erosion.

**Basin(s):** The basin has a permanent pool of water. The estimated depth of the pond is 1 foot. The side slopes are vegetated and no maintenance is required.

**Comments:** The northwest corner of the property is about to be developed. The site has been ringed with silt fence, and it looks like they are getting ready to open the ground up.

Remove vegetation and debris from inlets and outlets; stabilize with riprap.
