Project Review: SC2003-08  
Crystal Shopping Center Redevelopment: new buildings

**Inspection Date:** October 14, 2004

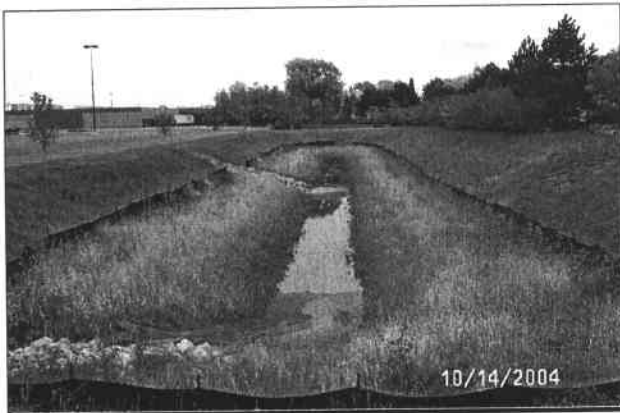
**Inlet (s):** West Pond - Bank failure adjacent to riprap. Erosion at sides of riprap at west and central inlets. Remove sediment from west and central areas of pond.

**Outlet(s):** West Pond - Outlet in good condition.

**Basin(s):** West Pond - Remove silt fence from west pond. Should have permanent pool.

**Comments:** Remove silt fence from west pond. Repair erosion and bank failure of west pond.  
Remove concrete from east pond. Scarify soil to a depth of 18-24" to ensure infiltration will occur.

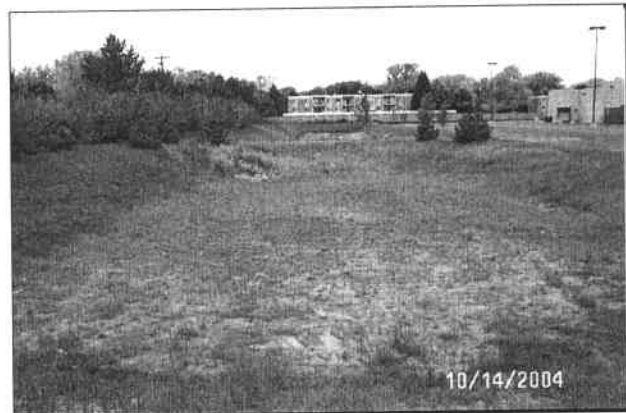
East Pond - No riprap at inlet from west pond.

East Pond - OK, outlet to city storm sewer.

East Pond - No permanent pool. Concrete washout area at northeast corner of pond.
