SHINGLE CREEK CORRIDOR STUDY

Reach 4 Palmer Lake

Figure 6

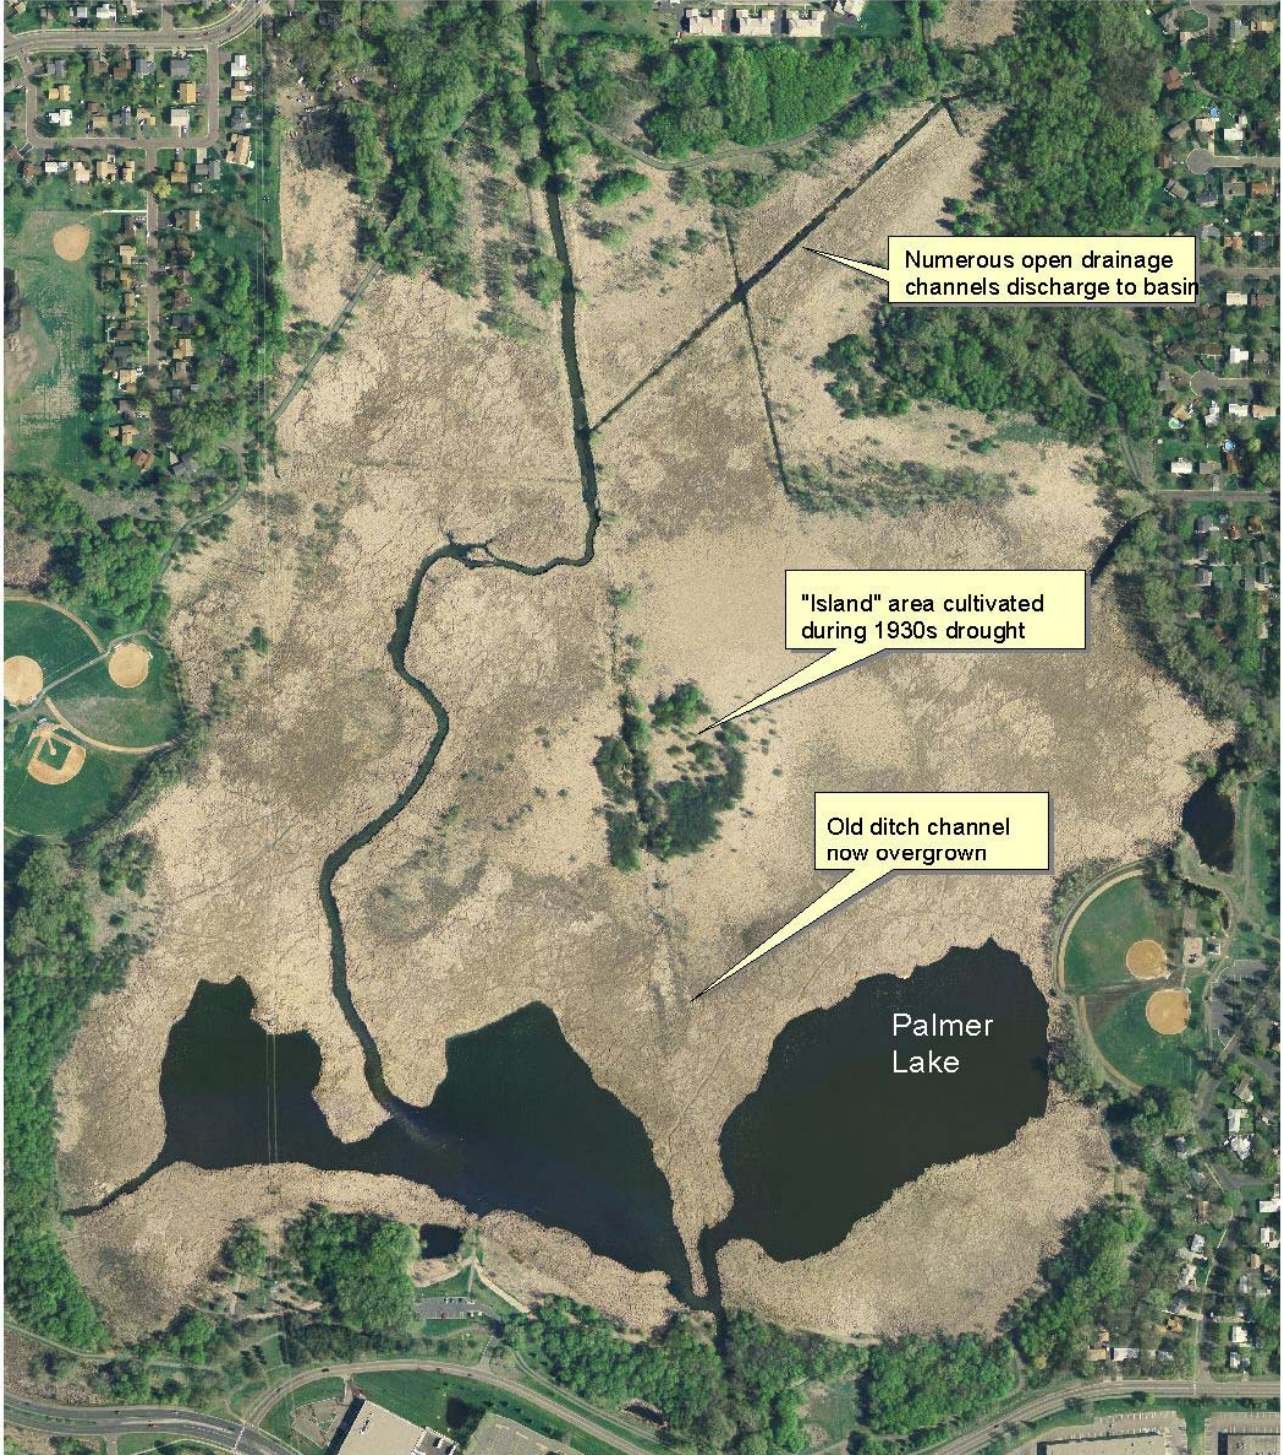
Numerous open drainage channels discharge to basin

"Island" area cultivated during 1930s drought

Old ditch channel now overgrown

Palmer Lake
