# DRAFT Lake Magda and Meadow Lake Nutrient TMDL Five Year Review

Prepared for:  
**Shingle Creek**  
Watershed Management Commission

**WENCK Associates, Inc.**  
7500 Olson Memorial  
Highway  
Phone: 763-4252-6800  
Fax: 952-831-1268  
[www.wenck.com](http://www.wenck.com)

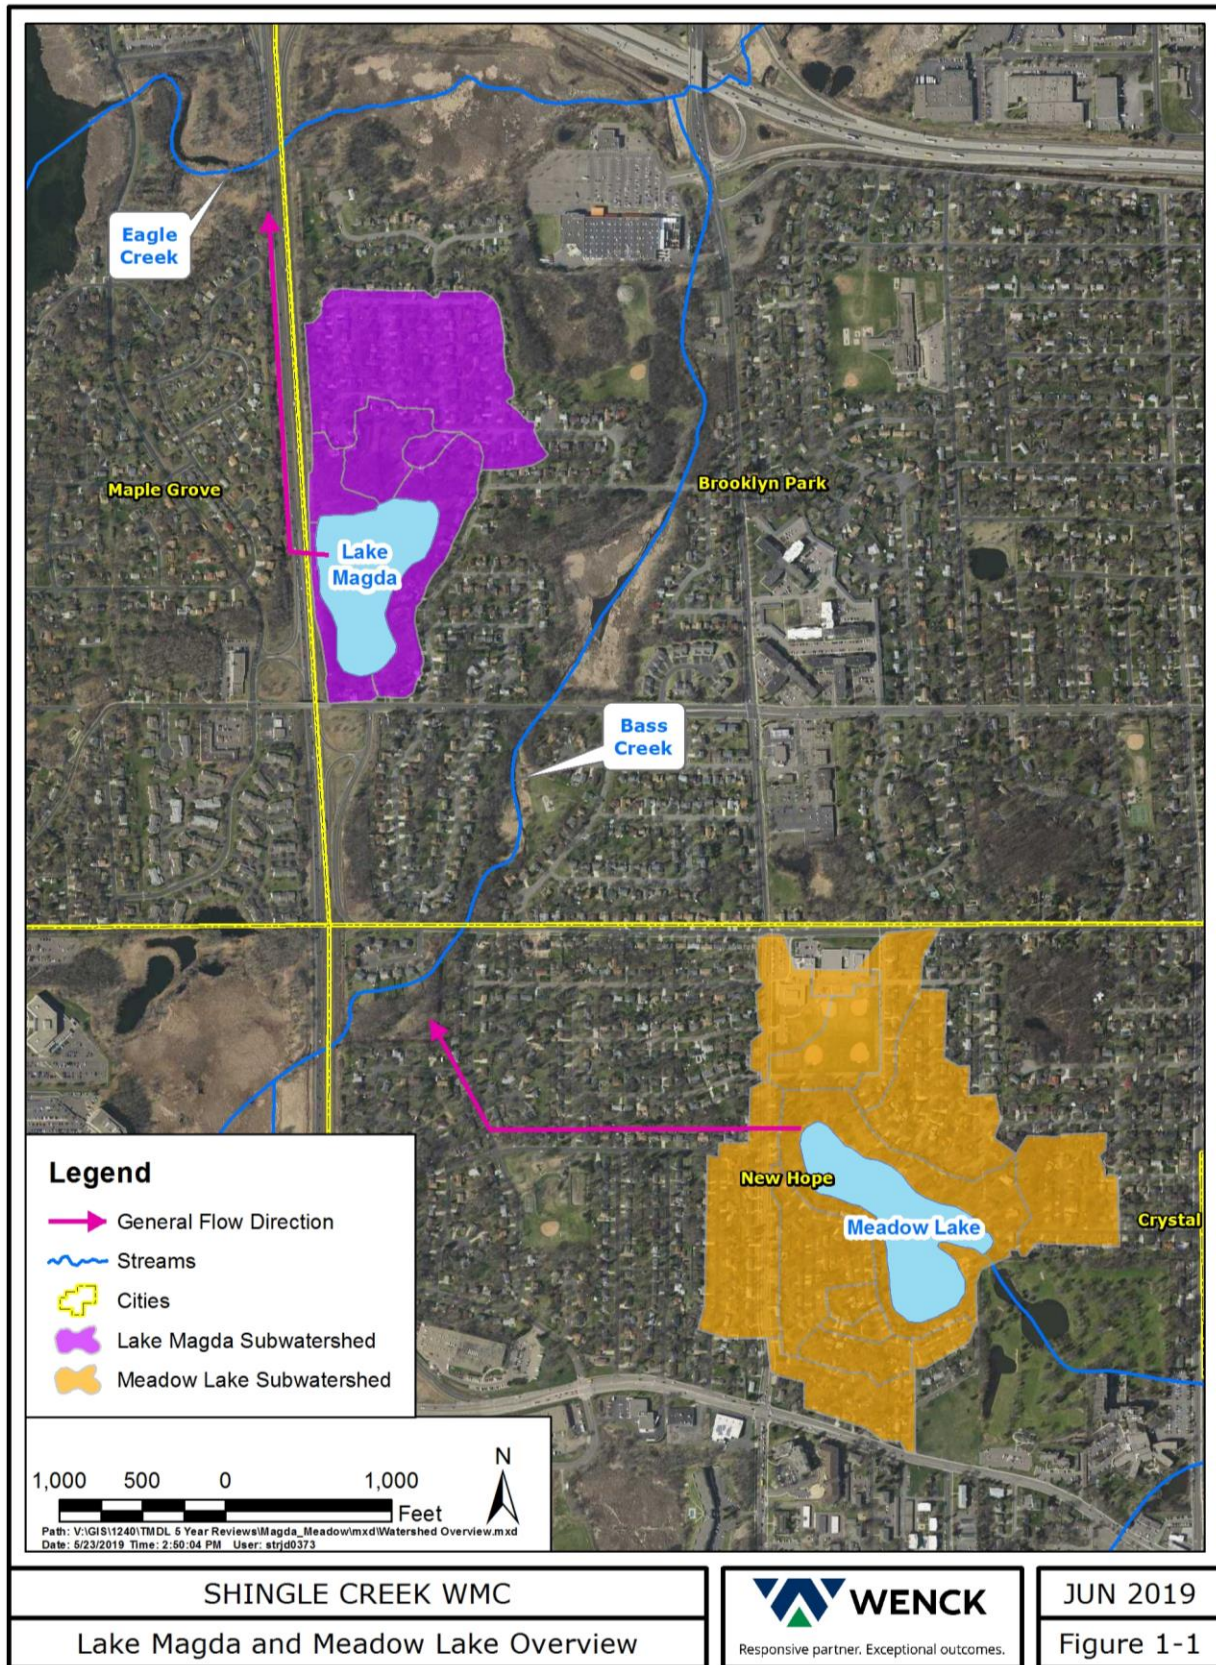
**Figure 1-1. Lake Magda and Meadow Lake lakesheds.**

Lake Magda and Meadow Lake are located in the Cities of Brooklyn Park and New Hope, respectively (Figure 1-1). Both lakes are considered shallow lakes and have maximum depths less than 10 feet. Lake Magda drains to Eagle Creek, a tributary to Shingle Creek, via a channel that flows north along Highway 169. Meadow Lake discharges to Bass Creek, also a tributary to Shingle Creek, via a 21-inch storm sewer on the northwest corner of the lake. The entire drainage area of Lake Magda (43 acres) and Meadow Lake (88 acres) are located in the Cities of Brooklyn Park and New Hope, respectively, and consist of fully developed urban and suburban land.

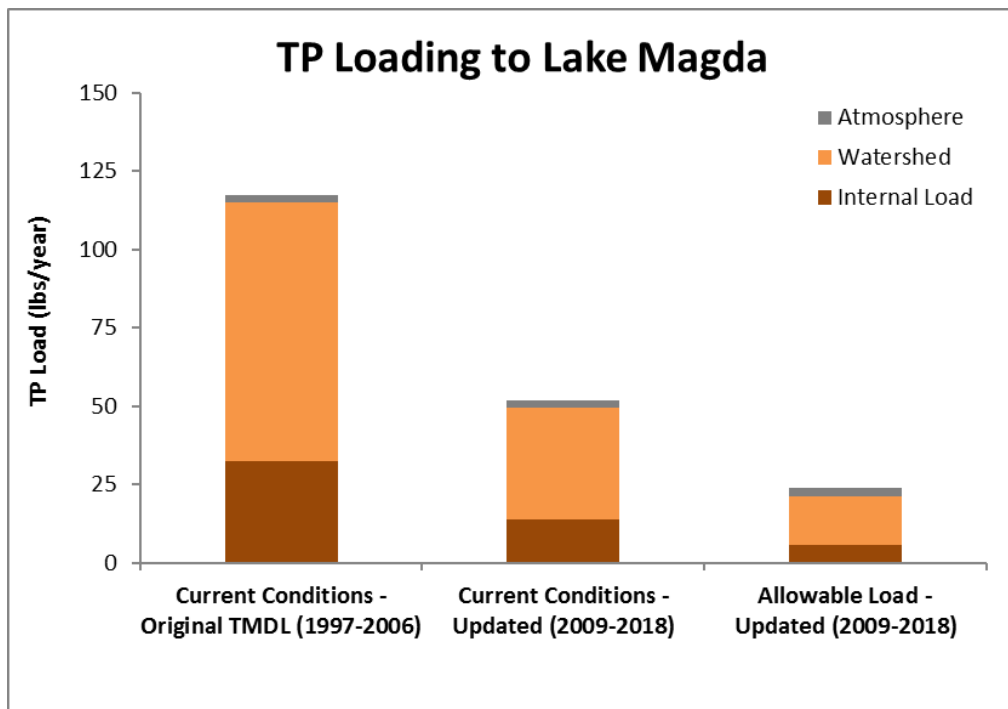
**Figure 3-1. Current conditions and updated allowable load targets for Lake Magda.**

The updated lake response model for Lake Magda suggests watershed loading will need to be reduced by approximately 20 lbs/year and internal load by 8 lbs/year. It should be pointed out that these load reduction requirements are significantly lower than the original TMDL study due to improved TP concentrations in Magda Lake. Average annual TP concentration for Lake Magda at the time of the original TMDL study (model years 1999, 2000, 2003, and 2006) was 140 µg/L. Average annual in-lake TP concentrations over the most recent ten year period (model years 2009, 2012, and 2017) is 101 µg/L. Table 3-1 summarizes existing TP loads from each major source and their required reduction based on the updated models. Figure 3-1 shows how our understanding of the existing and allowable TP loads in Meadow Lake have changed since the original TMDL study.

The original TMDL model for Lake Magda used 2000 as a base year for estimating the existing nutrient loading and TMDL allocations. The original TMDL model called for watershed and internal TP load reduction goals of approximately 59 lbs/year and 21 lbs/year, respectively (Table 1-1).

Existing TP Load [lbs/yr]	Allowable TP Load [lbs/yr]	Estimated Load Reduction	
					lbs/yr	Percent
Lake Magda	Wasteload	Watershed MS4	35.7	15.5	20.2	57%
	Load	Atmospheric	2.6	2.6	0	0%
		Internal	13.6	5.8	7.8	57%
	TOTAL LOAD			51.9	23.9	28.0

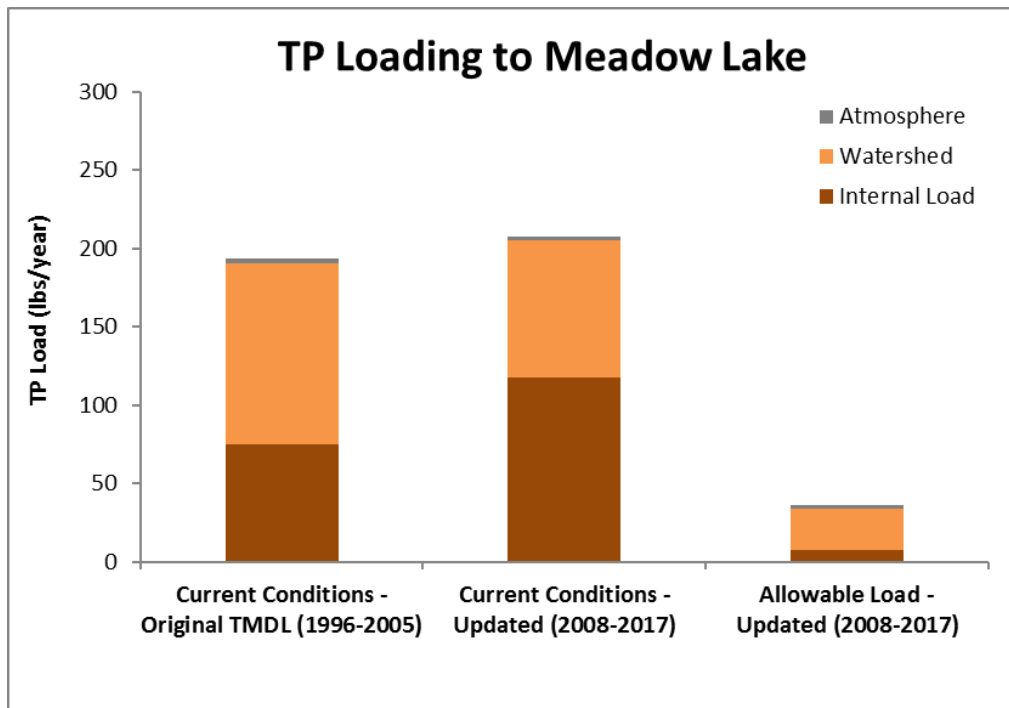
**Figure 3-2. Current conditions and updated allowable load targets for Meadow Lake.**

The updated lake response model for Meadow Lake suggests watershed loading will need to be reduced by approximately 62 lbs/year and internal load by 110 lbs/year. The updated load reduction requirements are similar to the original TMDL study since TP concentrations have remained relatively consistent in Meadow Lake over the past 20 years. Average annual TP concentration for Meadow Lake at the time of the original TMDL study (model years 1996, 1999, 2002, and 2005) was 239 µg/L. Average annual in-lake TP concentrations over the most recent ten year period (model years 2008, 2011, 2014, and 2016) is 249 µg/L. Table 3-1 summarizes existing TP loads from each major source and their required reduction based on the updated models. Figure 3-1 shows how our understanding of the existing and allowable TP loads in Meadow Lake have changed since the original TMDL study.

The original TMDL model for Meadow Lake used 1999 as a base year for estimating the existing nutrient loading and TMDL allocations. The original TMDL model called for watershed and internal TP load reduction goals of approximately 96 lbs/year and 62 lbs/year, respectively (Table 1-1).

Existing TP Load [lbs/yr]	Allowable TP Load [lbs/yr]	Estimated Load Reduction	
					lbs/yr	Percent
Meadow Lake	Wasteload	Watershed MS4	87.2	25.7	61.5	71%
	Load	Atmospheric	2.8	2.8	0.0	0%
		Internal	117.7	7.7	110.0	93%
	TOTAL LOAD			207.7	36.2	171.5
