# Meadow Lake Drawdown Feasibility Report

*Prepared for:*  
**City of New Hope, MN  
Shingle Creek  
Watershed Management Commission**

**WENCK Associates, Inc.**  
7500 Olson Memorial Hwy  
Golden Valley, MN 55427  
Phone: 763-2529-6800  
Wenck.com

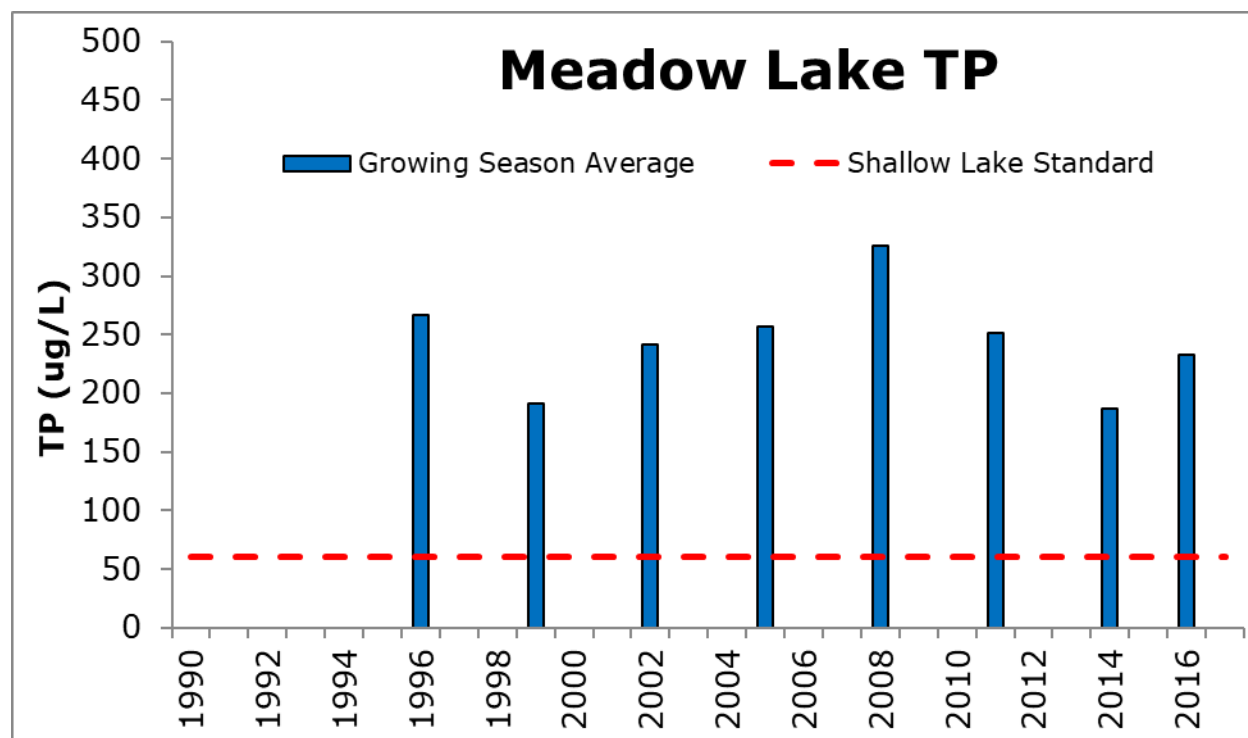
**Figure 2-2. Meadow Lake historic summer total phosphorus (TP) concentrations.**

Figures 2-2, 2-3, and 2-4 show the summer average total phosphorus (TP) and chlorophyll-a concentrations and summer average Secchi depth. The dashed red horizontal line indicates the applicable state water quality standard for this ecoregion.

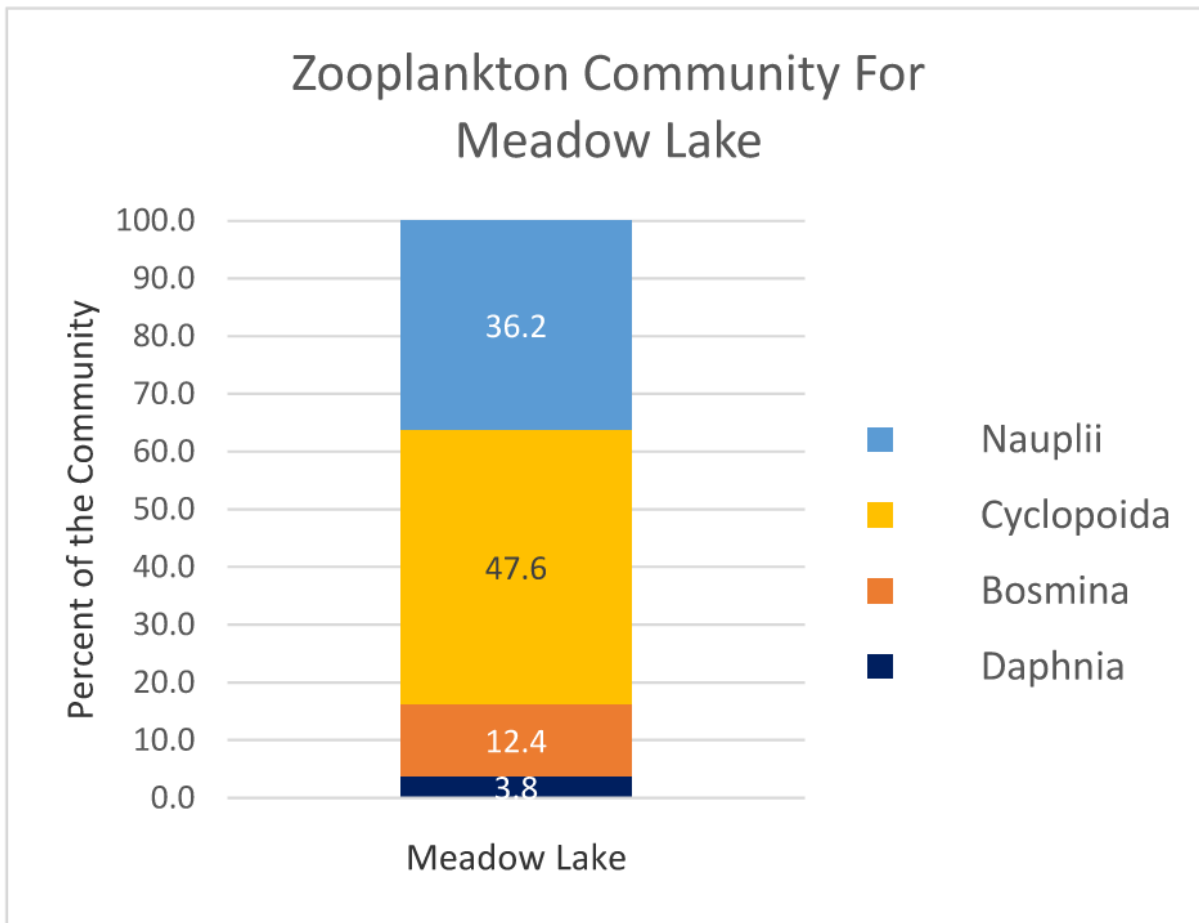
**Figure 2-5. Zooplankton community for Meadow Lake sampled in summer 2020.**

Phytoplankton and zooplankton surveys were completed in summer 2020. Cyanobacteria and dinoflagellates were present in the phytoplankton sample, a typical community for a shallow Minnesota lake in the late summer. The concentrations of both phytoplankton types were low and not near nuisance levels. The zooplankton community was dominated by copepods (cylopoida and nauplii), but daphnia and bosmina were also present (Figure 2-5). These zooplankton are ubiquitous in lakes and most common in lakes with a healthy submersed vegetation community. The phytoplankton and zooplankton data provide a snapshot of the summer, pre-drawdown community.

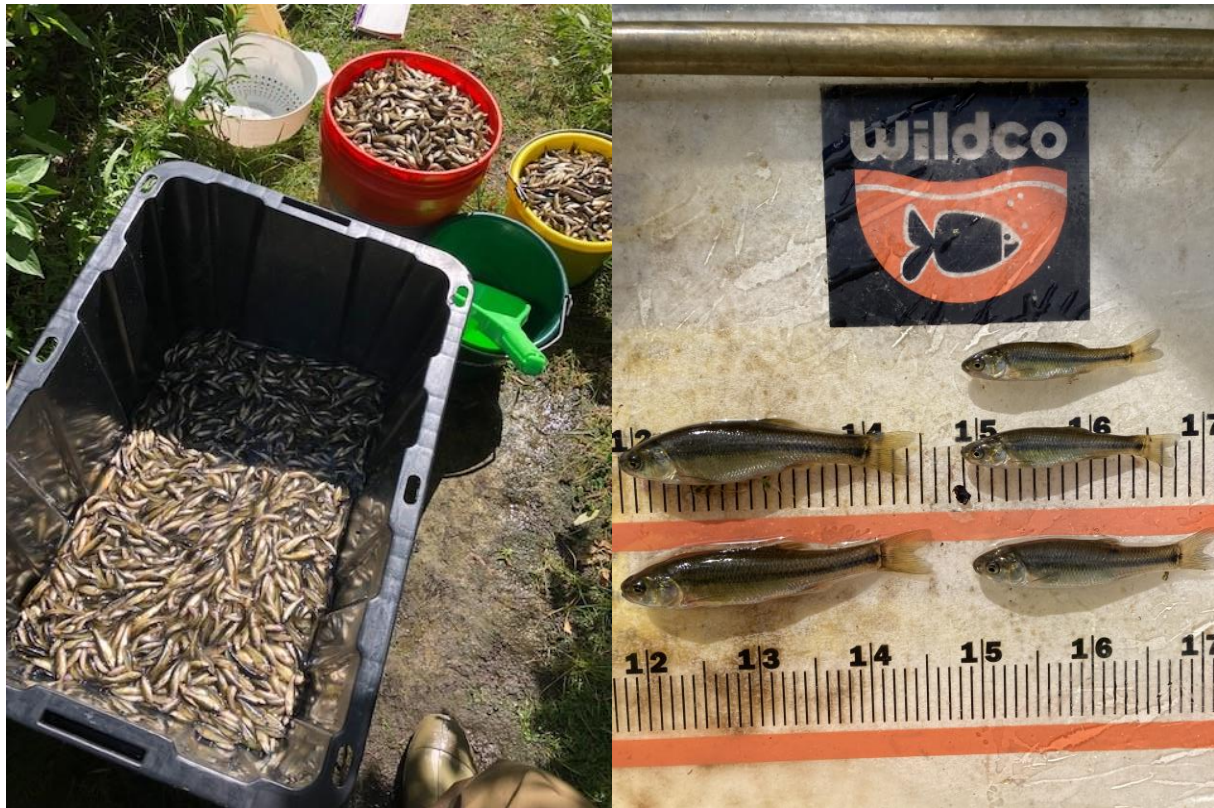
**Figure 2-6. Over 30,000 fathead minnows captured (left) and their size distribution (right) from the 2020 survey.**

A fisheries assessment was completed on Meadow Lake in early August 2017. Only two species were observed during the 2017 assessment and the population was dominated by fathead minnow. A follow-up assessment was completed in September 2020. Fathead minnows were the only fish captured during the 2020 assessment. Rusty crayfish (*Orconectes rusticus*) and painted turtles (*Chrysemys picta*) were captured as bycatch. Table 2.2 summarizes fish sampling data.

Previous surveys conducted on Meadow Lake by others for academic research showed that the minnow population varies significantly annually, with sampling some years finding no minnows and some years thousands of individuals. Fathead minnow are very tolerant of winter-kill conditions; however, Meadow Lake is likely not deep enough to support the species year-round. Fish may over winter in the adjacent golf course ponds and/or recolonize the lake from Bass Creek during high water levels. Minnows could also be introduced by human sources, such as dumping a bait bucket into the lake. In high densities, fathead minnow can have significant water quality impacts through feeding on zooplankton, secretion, and sediment resuspension. Thus, it is highly likely that fathead minnows contribute to poor water quality conditions in Meadow Lake.

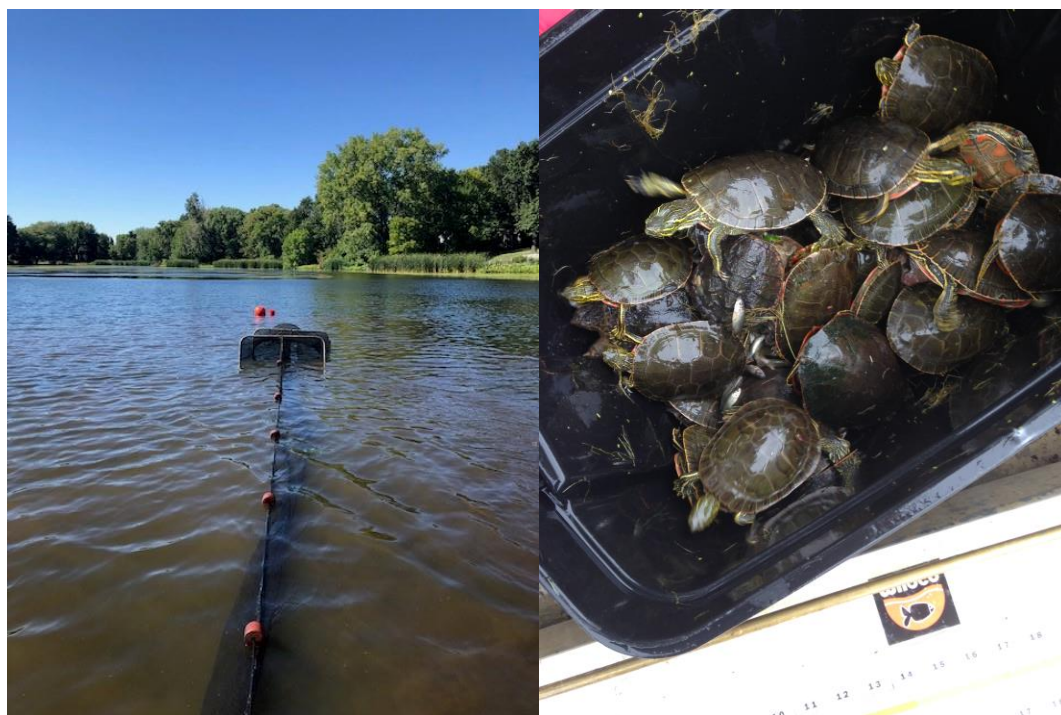
**Figure 2-8. Mini-fyke net deployed in Meadow Lake in September 2020 (left) and turtles incidentally caught in the 2017 fish survey (right).**

Lakeshore property owners have observed snapping (*Chelydra serpentine*) and painted turtles in the lake. In 2011 and 2017, fish surveys counted turtles incidentally caught in mini-fyke nets. A visual point survey was conducted in 2020 to document turtle species and their relative abundance in Meadow Lake. No threatened or endangered turtle species have been observed in Meadow Lake.

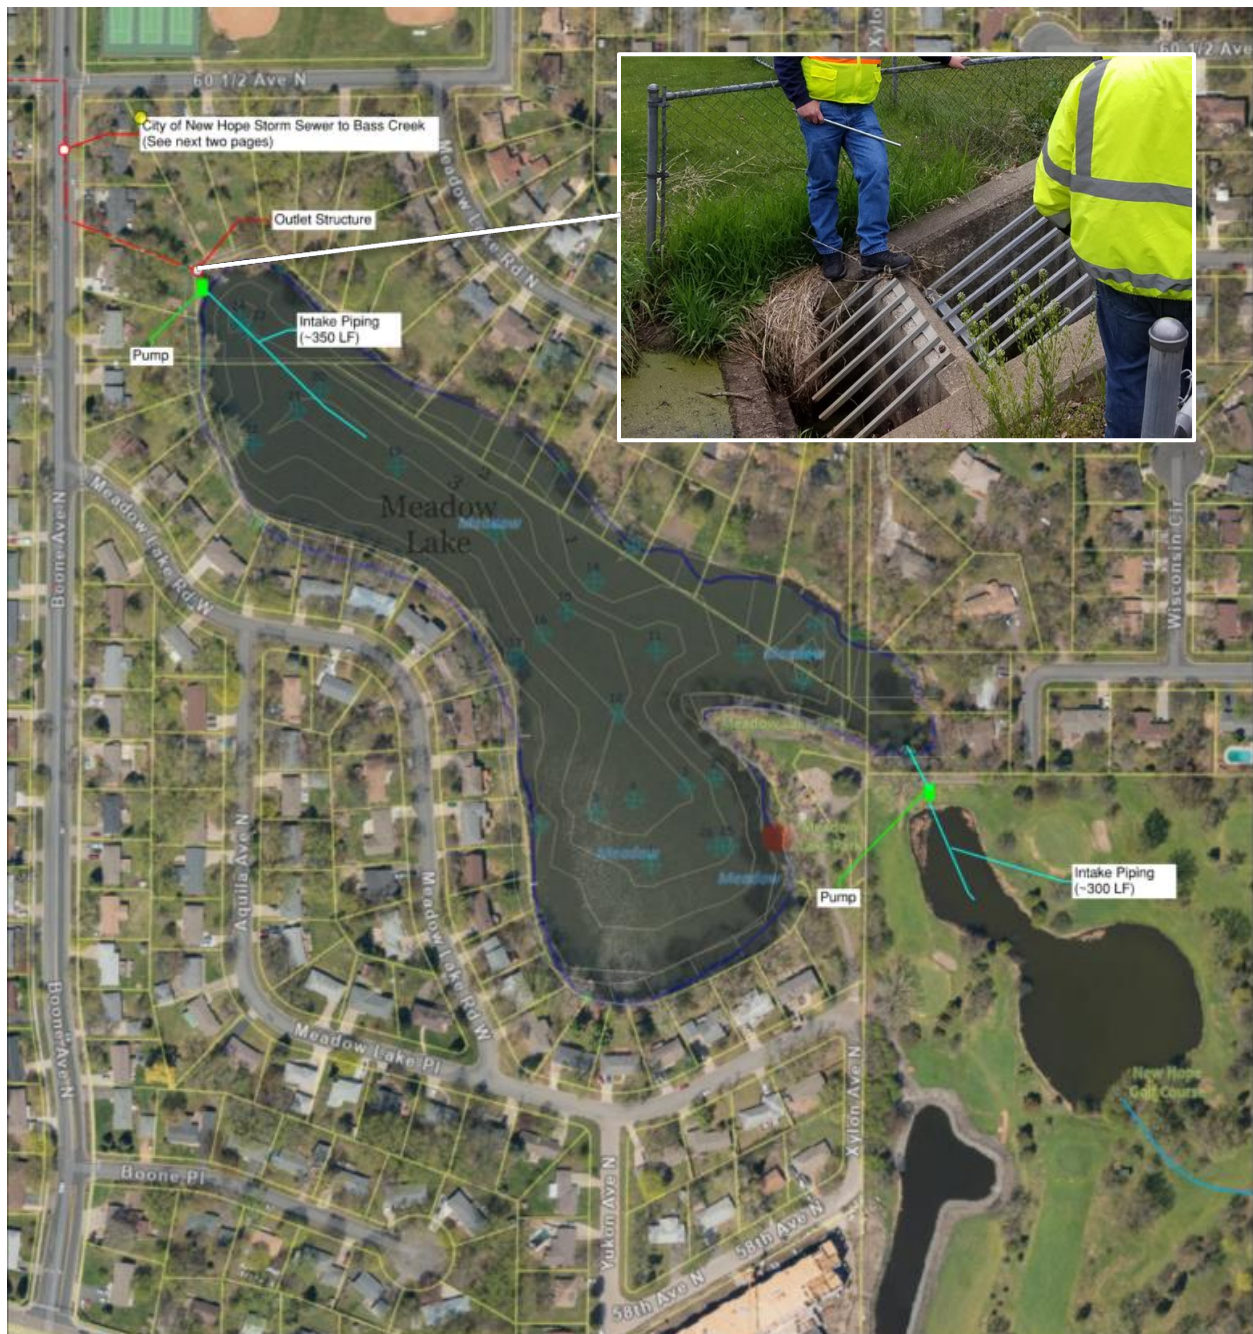
**Figure 4-1. Drawdown pumping schematic plan and outlet structure.**

The proposed drawdown would begin as soon as permitted, ideally by October 2021. Two 6" diesel dewatering pumps (1.34 cfs each) would be installed in the backyard of a residence in the northwest corner of the lake (see Figure 4-1.) The property owners have provided permission for this installation. The pump will be enclosed in an insulated wooden box to minimize noise and to insulate the pump from freezing temperatures. Silent exhaust kits would also be installed to further reduce noise

Approximately 350 feet of 8" intake hose will be extended out to the deepest contour of the lake (the maximum depth is 3.58 feet). A 6" discharge pipe would be directed to the downstream side of the outlet's weir wall (Figure 4-1.) A similar setup would be repeated at the south end of the lake to pump water from the golf course pond to Meadow Lake. This would then allow the City to replace the culvert between the golf course pond and Meadow lake after drawdown is completed

The pump is proposed to be operated 7:00 am – 5:00 pm (10 hours) weekdays for about 17 days to achieve the initial, full drawdown of the lake. Thereafter, the pump will be operated following rain events, or when the depth of the lake reaches 0.25'. The City's consultant Stantec will subcontract with Iron Eagle Industrial Services staff who will operate and maintain the pump. Iron Eagle is a 24/7/365 emergency response operation which is located approximately one mile from Meadow Lake. Staff at Iron Eagle will be responsible for set up, operation, daily maintenance, and tear down of the pumps during the draw down. Once the drawdown is complete, Iron Eagle staff will visit the site daily to observe the rate of groundwater seepage and side slope weeping and confer with the project engineer to estimate how frequently "maintenance" pumping should occur. As noted later in this report, a small shallow pool will be left to provide a winter refuge for turtles.

The expected drawdown volume is 26.1 acre-feet. Based on Meadow Lake's surveyed bathymetry and estimated values from the Golf Course Pond, the volume below the Normal Water Level is 17.1 acre-feet. The estimated volume was multiplied by 1.25 to conservatively estimate the additional volume expected to enter the lake from the saturated side-slopes. The two 600 GPM diesel pumps are estimated to achieve a conservative 2.2 cfs of pumping after losses through the intake/discharge piping. This assumes the pump is operating at 82% efficiency and there will be a base flow of 0.2 cfs. The baseflow of 0.2 cfs
