Cedar Island, Pike and Eagle Lakes Nutrient TMDL Five Year Review

Prepared for:
Shingle Creek Watershed Management Commission 3235 Fernbrook Lane
Plymouth, MN 55447
shinglecreek.org

WENCK Associates, Inc.
7500 Olson Memorial
Highway
Phone: 763-4252-6800
Fax: 952-831-1268
www.wenck.com

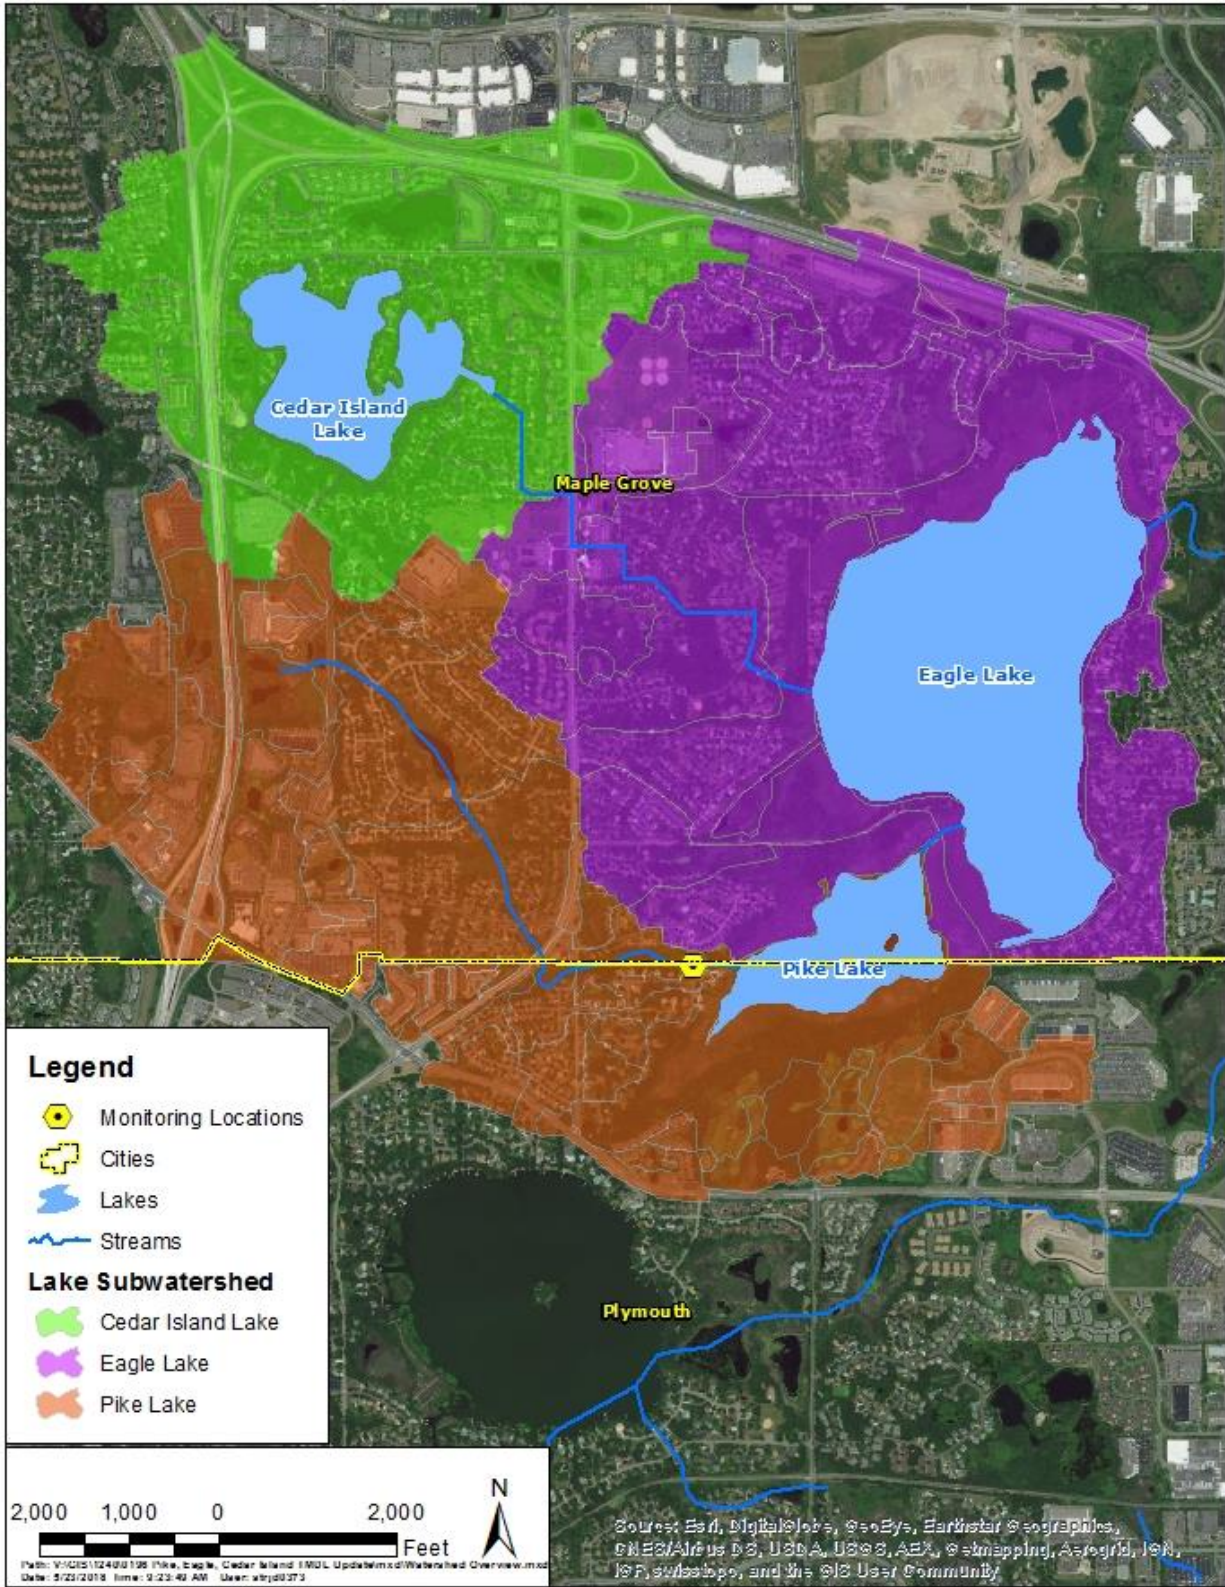
Figure 1-1. Cedar Island, Pike and Eagle Lake lakesheds.

Cedar Island, Pike and Eagle Lakes are located in the Cities of Maple Grove and Plymouth (Figure 1-1). Cedar Island and Pike Lakes are considered shallow lakes, and Eagle is classified as a deep lake. Pike Lake drains to Eagle Lake via a channel through a large wetland between the two lakes. Cedar Island Lake has no natural outlet, but discharges to Eagle Lake through a pumped outlet. Eagle Lake discharges into Eagle Creek, which is a tributary of Shingle Creek.

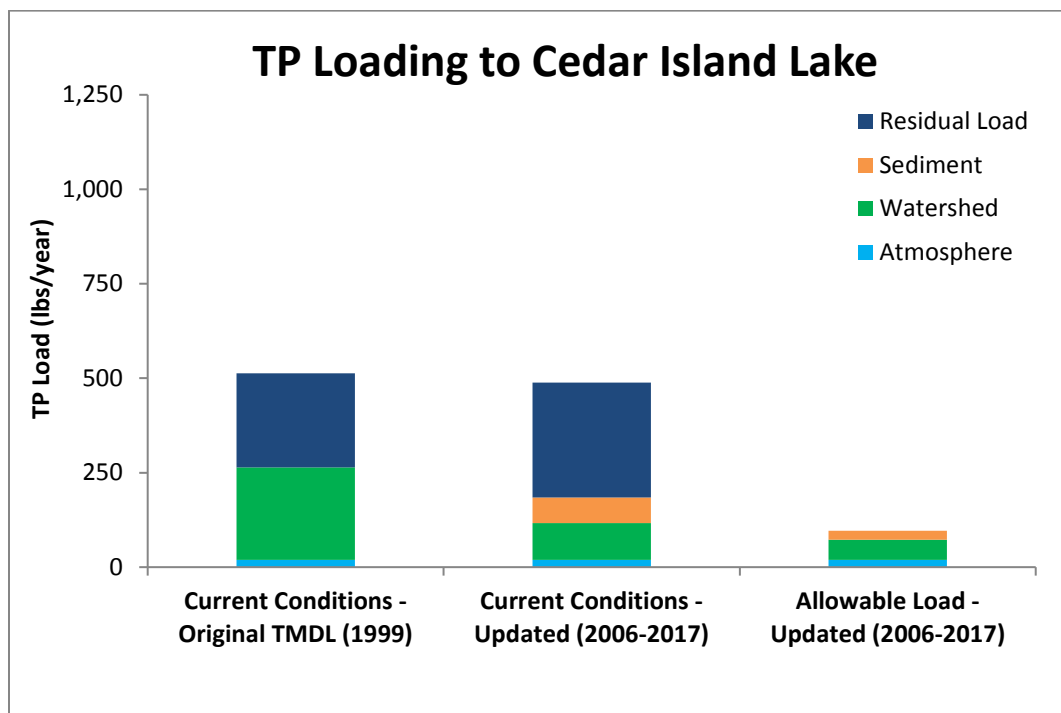
Figure 3-1. Current conditions and updated allowable load targets for Cedar Island Lake.

The original TMDL models used 1999 as a base year for estimating the existing nutrient loading and TMDL allocations for Cedar Island Lake. The original TMDL model called for watershed and residual/internal TP load reduction goals of approximately 138 lbs/year and 208 lbs/year, respectively (Table 1-1). Recent in-lake monitoring, lift station data, and sediment core collection and analysis have greatly improved our understanding of the current condition TP budget Cedar Island Lake. The updated lake response model suggests a residual load of 304 lbs/yr for Cedar Island Lake. This load represents additional load needed to calibrate the lake response model to in-lake monitored data. The source of the residual load is unknown at this time, however it could include inputs from one or several sources such as rough fish and/or an imbalanced fishery, CLP senescence, and wind/wave action from wind or boating/recreation. In order for Cedar Island Lake to meet State water quality standards, the source of residual load will need to be identified and removed and/or managed appropriately. Additionally, watershed loading will need to be reduced by approximately 44 lbs/year and sediment release of phosphorus by 45 lbs/year (Table 3-1). Figure 3-2 shows how our understanding of the existing and allowable TP loads in Cedar Island Lake have changed since the original TMDL study.

Existing TP Load [lbs/yr]	Allowable TP Load [lbs/yr]	Estimated Load Reduction	
					lbs/yr	Percent
Cedar Island	Wasteload	Watershed MS4	98	54	44	45%
	Load	Atmospheric	19	19	0	0%
		Sediment	68	23	45	66%
		Residual	304	0	304	100%
	TOTAL LOAD		489	96	393	80%

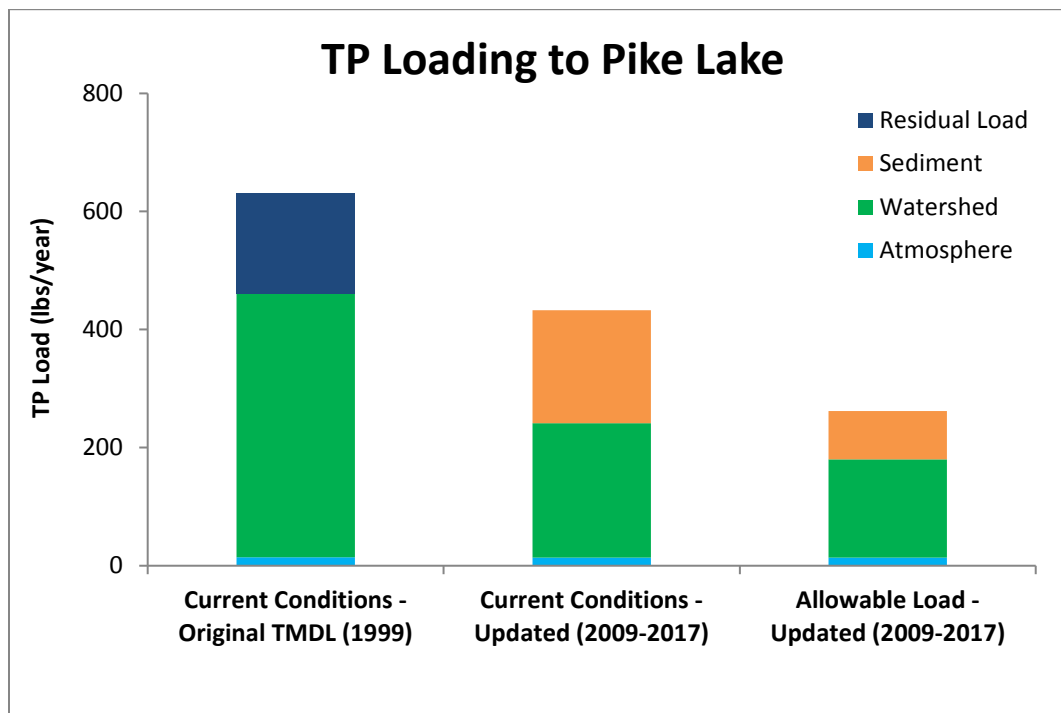
Figure 3-2. Current conditions and updated allowable load targets for Pike Lake.

Existing TP Load [lbs/yr]	Allowable TP Load [lbs/yr]	Estimated Load Reduction	
					lbs/yr	Percent
Pike	Wasteload	Watershed MS4	228	166	62	27%
	Load	Atmospheric	14	14	0	0%
		Sediment	191	82	109	57%
	TOTAL LOAD			433	262	171

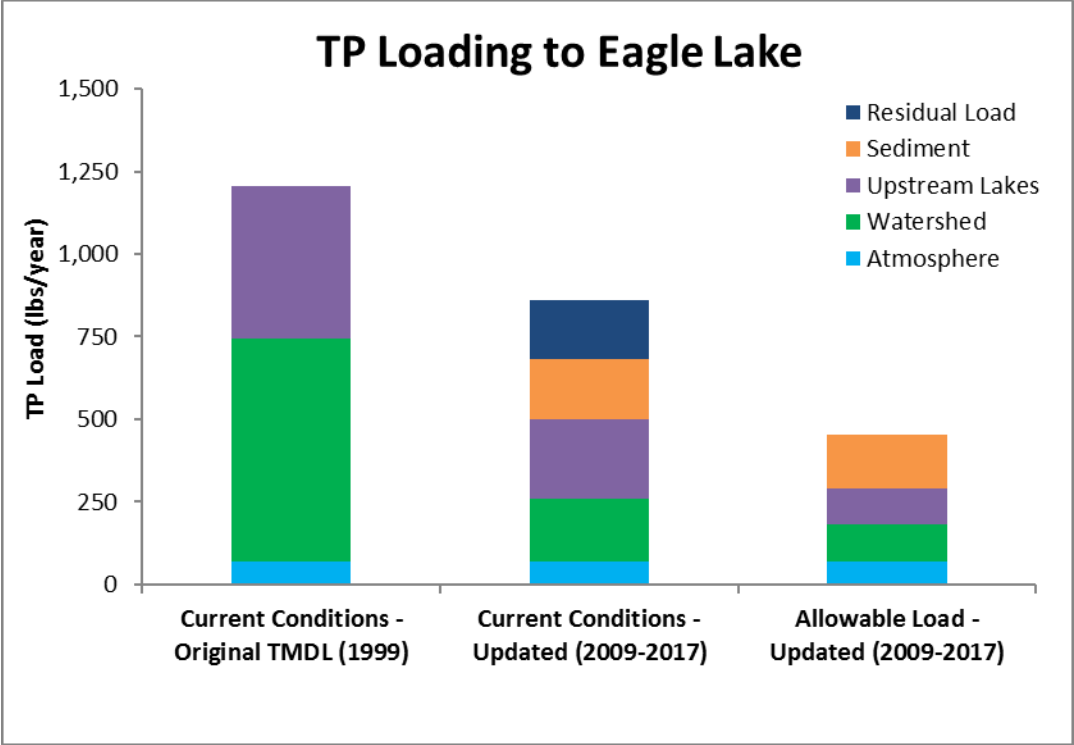
Figure 3-3. Current conditions and updated allowable load targets for Eagle Lake.

The original TMDL models used 1999 as a base year for estimating the existing nutrient loading and TMDL allocations for Eagle Lake. The original TMDL model called for watershed and upstream lake TP load reduction goals of approximately 264 lbs/year and 221 lbs/year, respectively (Table 1-1). Recent in-lake monitoring, stream monitoring, and sediment core collection and analysis have greatly improved our understanding of the current condition TP budget for Eagle Lake. The updated lake response model suggests upstream impaired lakes (Cedar Island and Pike Lakes) will need to achieve State water quality standards. Improvements in these lakes should result in TP load reductions to Eagle Lake of approximately 66 lbs/yr. Finally, watershed loading will need to be reduced by approximately 88 lbs/year and sediment release of phosphorus by 48 lbs/year (Table 3-1). Figure 3-2 shows how our understanding of the existing and allowable TP loads in Eagle Lake have changed since the original TMDL study.

Existing TP Load [lbs/yr]	Allowable TP Load [lbs/yr]	Estimated Load Reduction	
					lbs/yr	Percent
Eagle	Wasteload	Watershed MS4	209	121	88	42%
		Upstream Lakes	192	126	66	34%
	Load	Atmospheric	71	71	0	0%
		Sediment	219	171	48	22%
	TOTAL LOAD			691	489	202
