**Project Review:** SC2000-22  
Palmer Lake WQ & Trail Project: wetland alteration plan

**Project Location:** MAP: 21  
Brooklyn Center  
Adjacent to East Palmer Lake Park  
Replacement of drainage channel with 2 cell wetland mitigation

**Inspection Date:** October 12, 2004

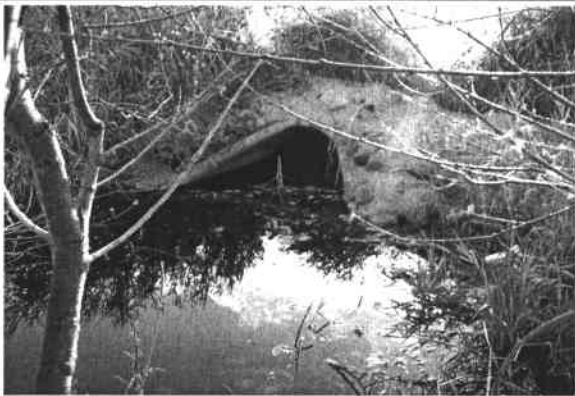
**Inlet (s):** Inlets well stabilized with grouted riprap.

Inlet

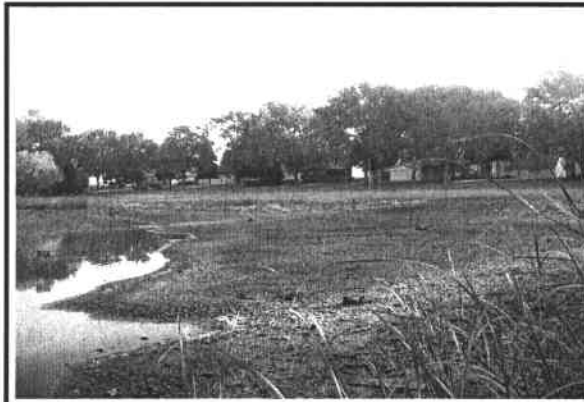
**Basin(s):** Vegetation on east side of pond not established due to water level fluctuations. Pond is wetland mitigation and issue addressed in mitigation annual reports.

East side; vegetation not established

**Comments:** Establish vegetation on east side of pond as required in annual wetland monitoring report.
