**Project Review:** SC2002-08  
Glacier Vista, 27-acre single- and multiple-family housing development

**Inspection Date:** October 12, 2004

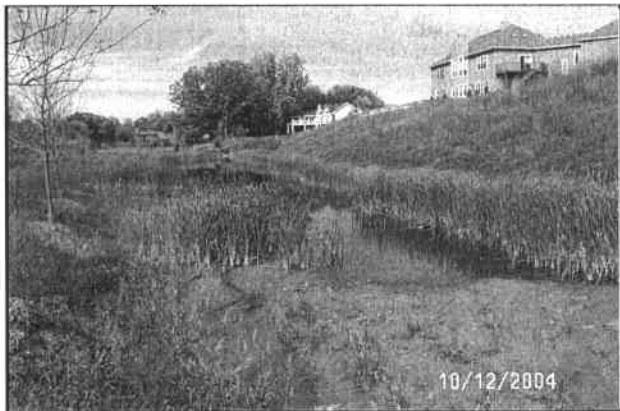
**Inlet (s):** The pond inlets are both stabilized with riprap. They are clear of debris and no maintenance is required at this time.

**Outlet(s):** The outlet is also clear of debris. Skimming is provided. No maintenance is required at this time. There is a stabilized emergency overflow spillway provided. It should be removed and reinstalled to make it flush or lower than the rest of the pond bank. Build it per plan.

**Basin(s):** A permanent pool is provided; the estimated depth is 2 to 4 feet. The side slopes are vegetated. No maintenance is required.
