Project Review:

WM2002-12

Hawthorn Bend: 29 acre residential

Inspection Date: August 25, 2005

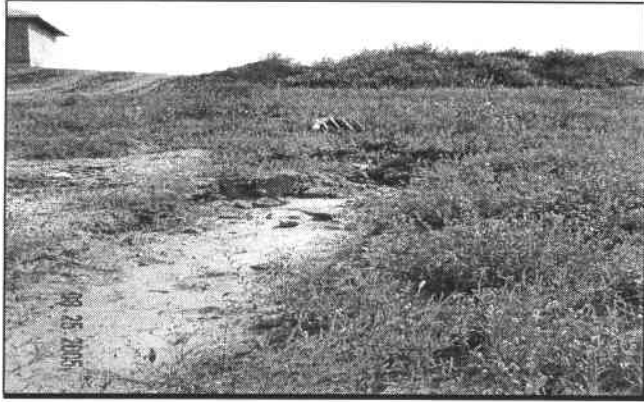
South Pond north of 103rd Avenue - erosion at southwest and north inlets; sedimentation at both inlets.

South pond-southwest inlet

South Pond north of 103rd Avenue - Repair erosion and remove sediment at both inlets. Reseed bare soil areas, as necessary.

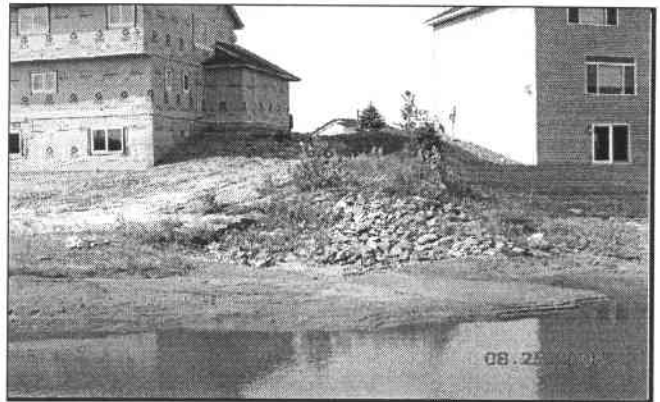
South pond-north inlet
