Project Review:

WM2003-12

Prairie Gardens: 50 single family homes

SE quad Douglas and 107th Pkwy
1 pond discharges to Oxbow Creek II wetland

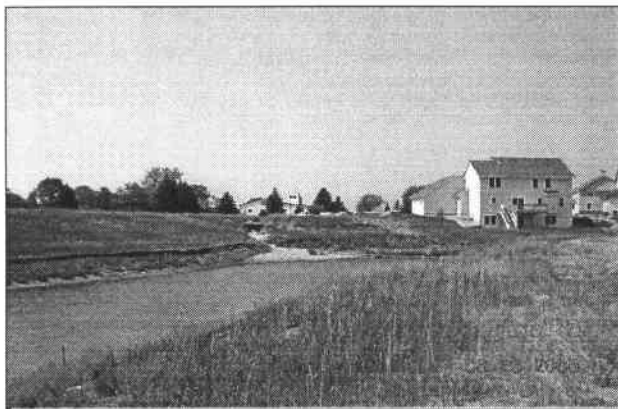
Basin(s): Vegetated with permanent pool, but severe erosion at southwest corner of pond.

Comments: Repair severe erosion at southwest corner of pond.
