SHINGLE CREEK CORRIDOR STUDY

Reach 6 Candlewood to Broadway

Figure 18

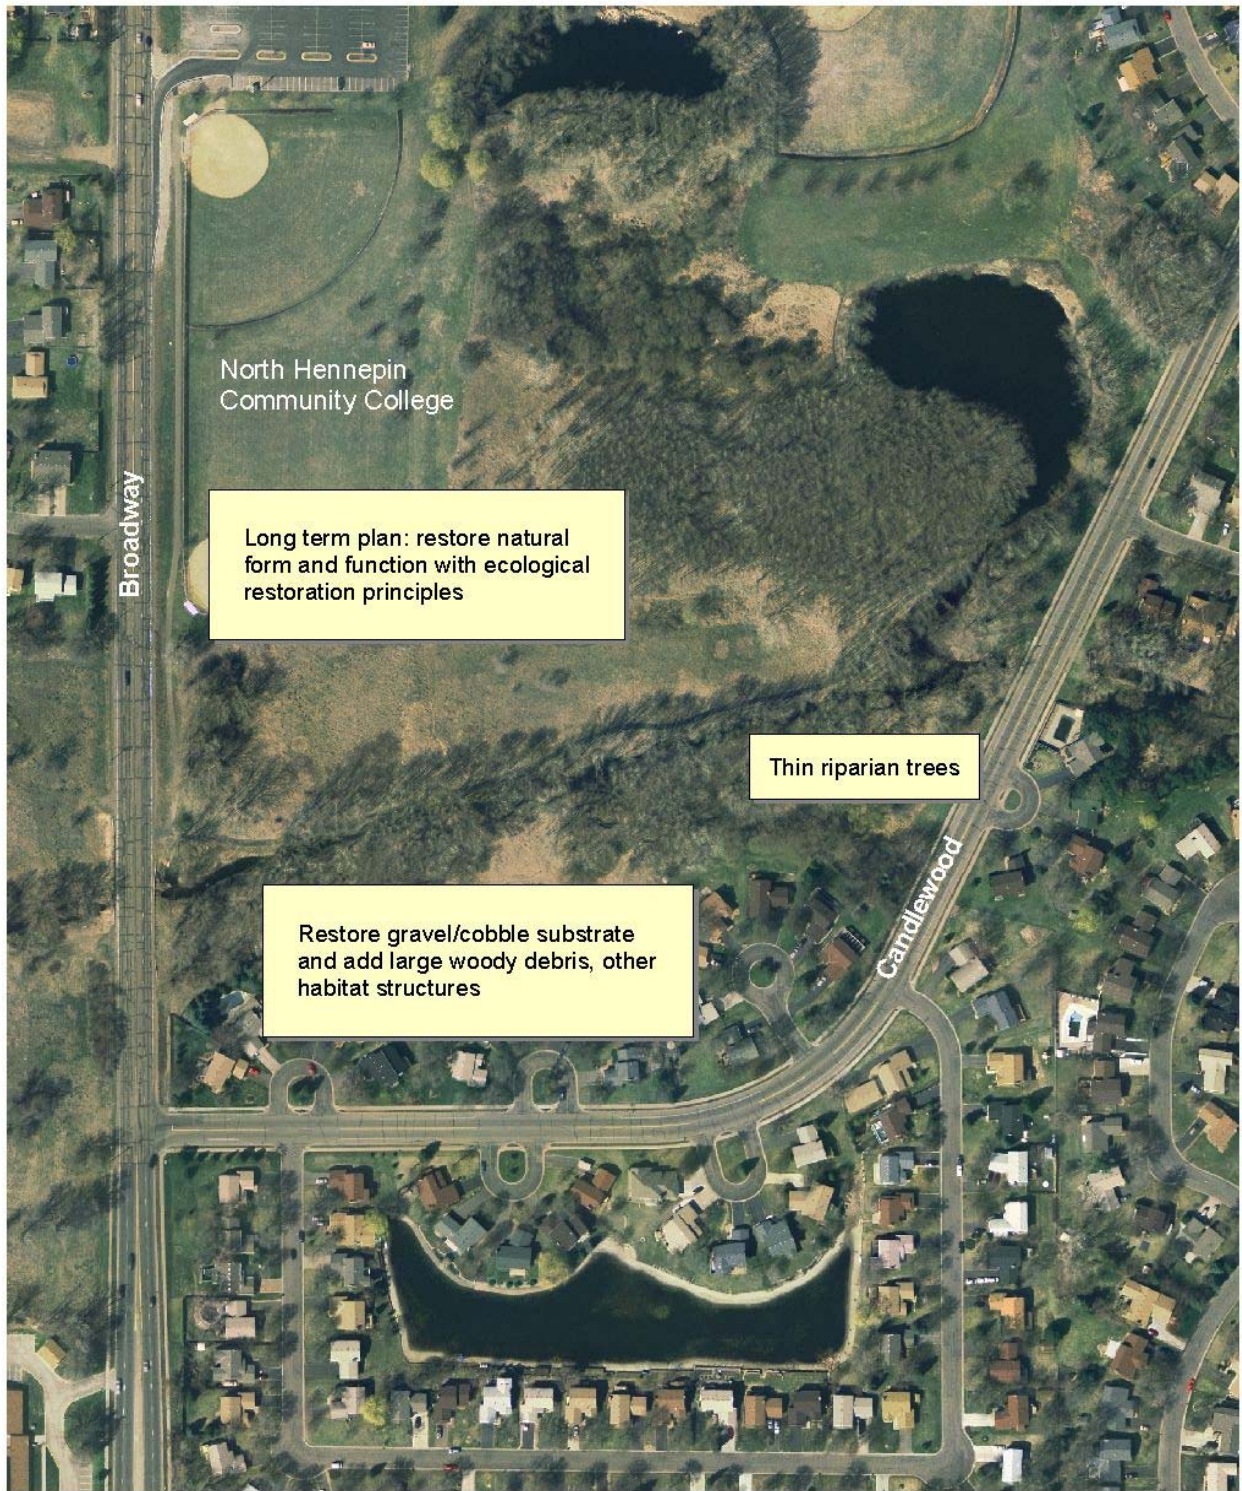
Long term plan: restore natural form and function with ecological restoration principles

Thin riparian trees

Restore gravel/cobble substrate and add large woody debris, other habitat structures
