**SHINGLE CREEK CORRIDOR STUDY**

Reach 3 I94 to 69th

Figure 4

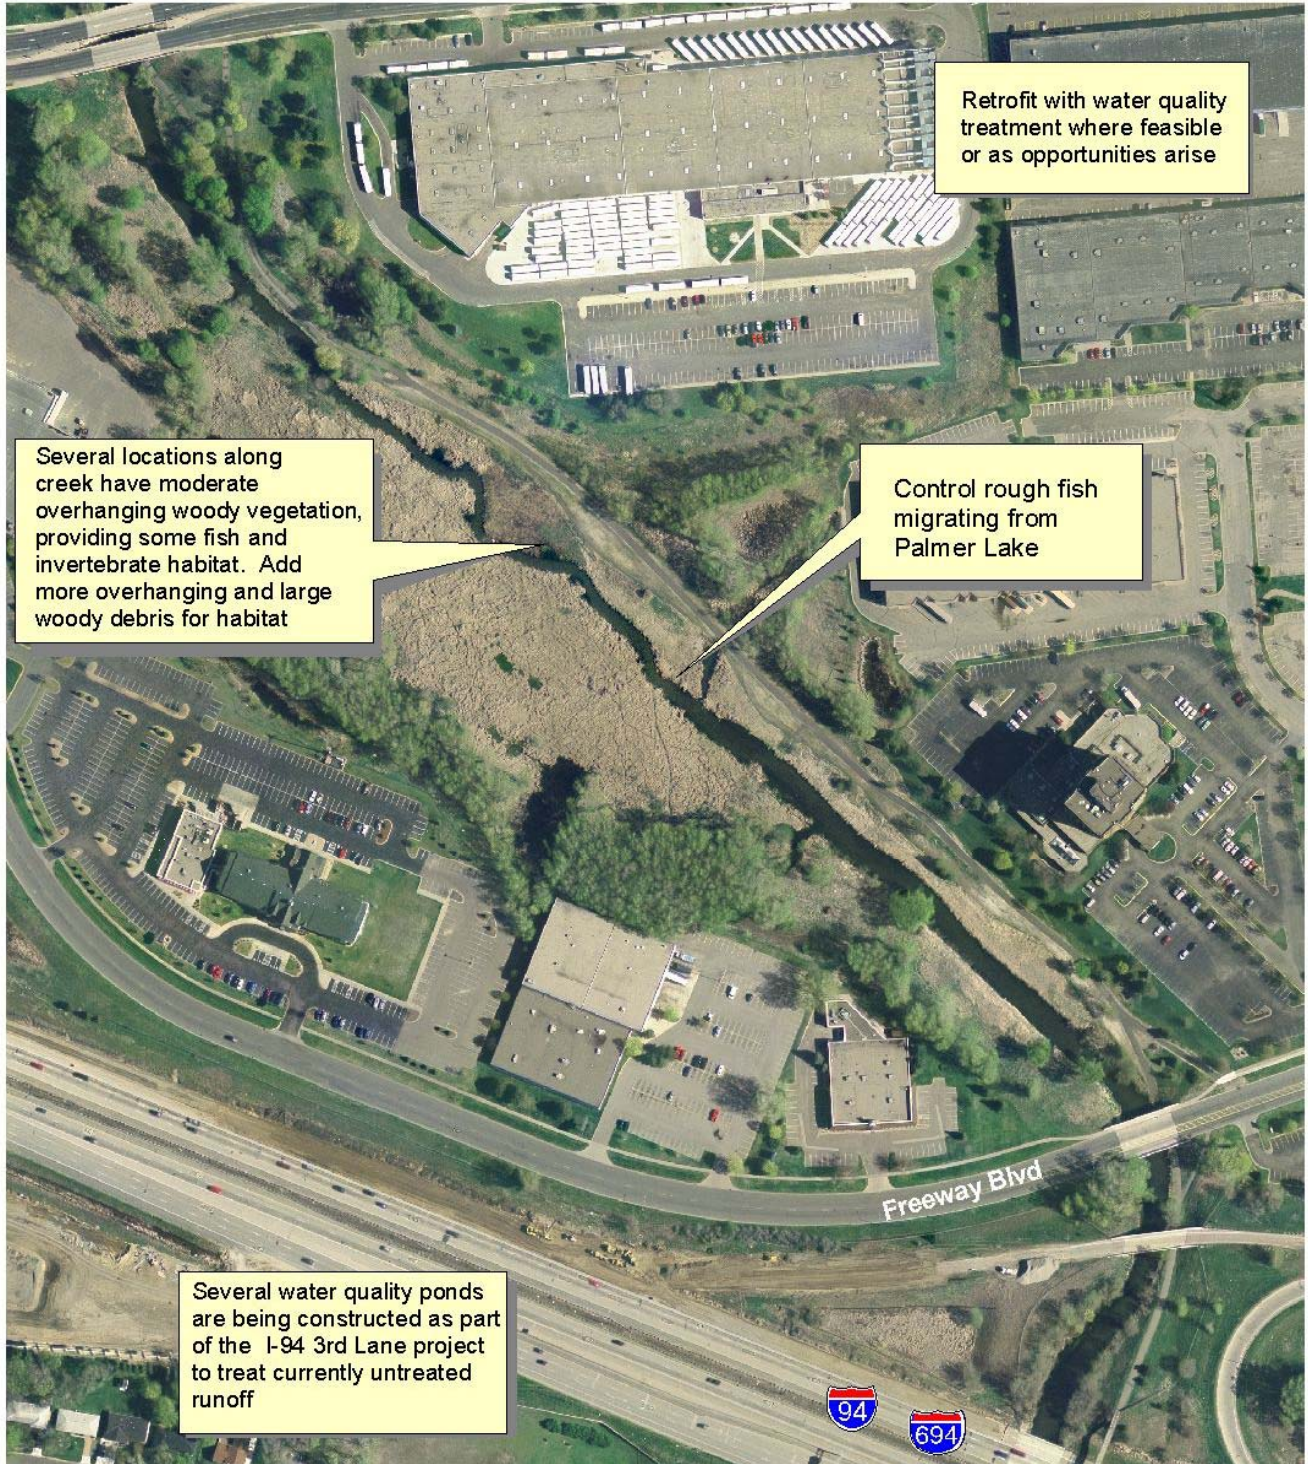
Several locations along creek have moderate overhanging woody vegetation, providing some fish and invertebrate habitat. Add more overhanging and large woody debris for habitat

Retrofit with water quality treatment where feasible or as opportunities arise

Control rough fish migrating from Palmer Lake

Several water quality ponds are being constructed as part of the I-94 3rd Lane project to treat currently untreated runoff
