SHINGLE CREEK CORRIDOR STUDY

Reach 5 Xerxes to Noble - Lower Reach

Figure 8

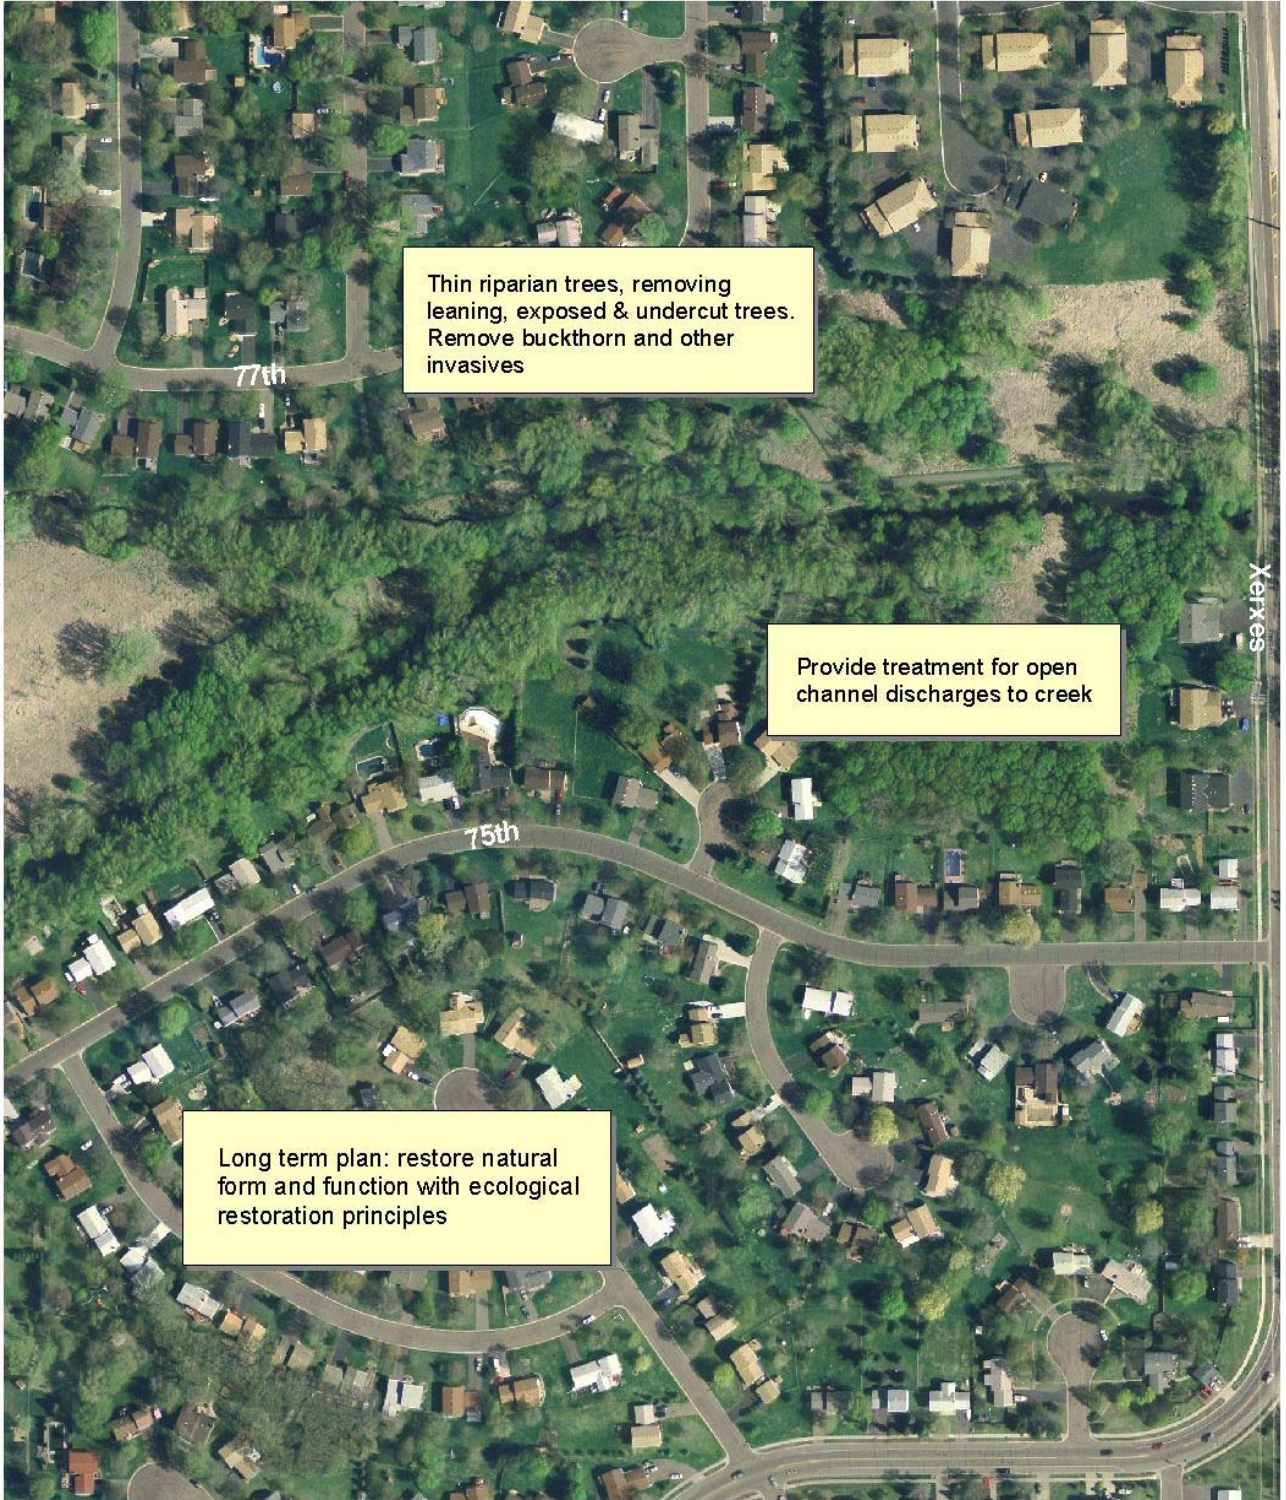
Thin riparian trees, removing leaning, exposed & undercut trees. Remove buckthorn and other invasives

Provide treatment for open channel discharges to creek

Long term plan: restore natural form and function with ecological restoration principles
